Upper Cabin Run Rehabilitation Project

DATE: April 18, 2008

SUBJECT: **PHOTO DOCUMENTATION OF CABIN RUN STREAM PROJECT**
(BEFORE AND AFTER DOCUMENTATION)

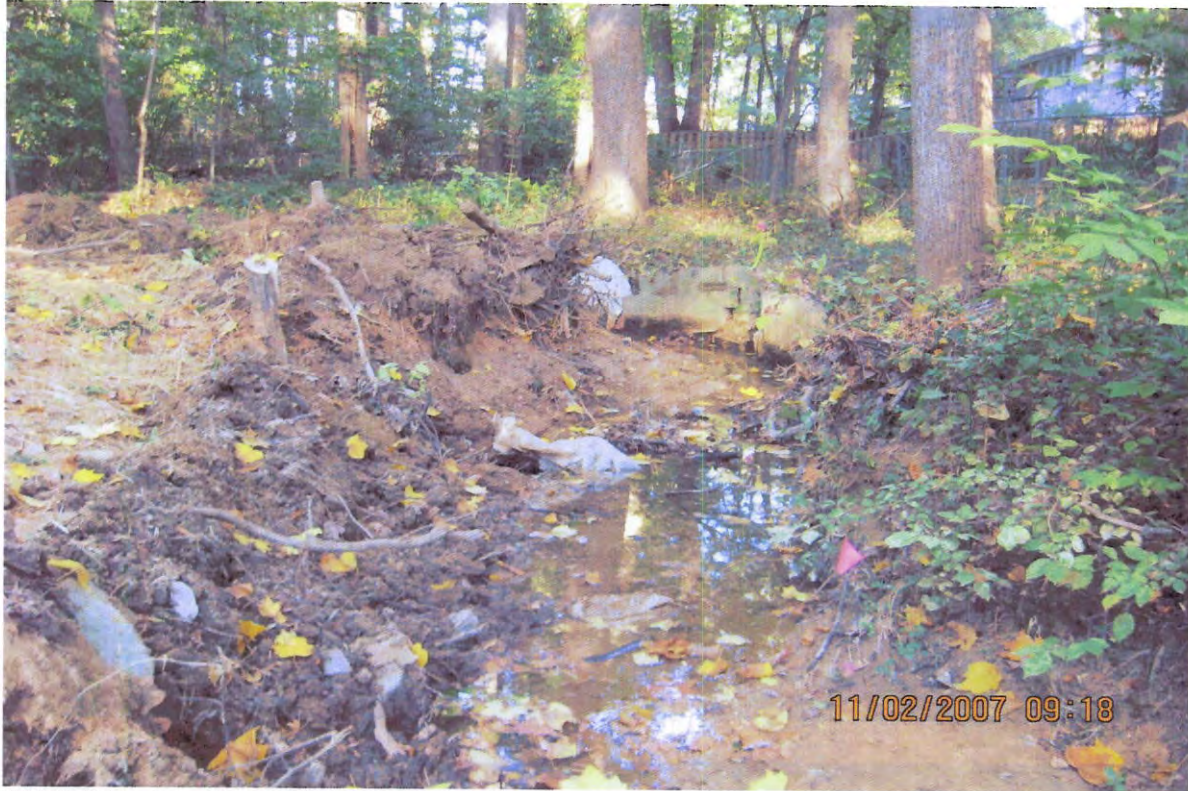
BEFORE - Location of #1 rock weir. (Photo zone 1)

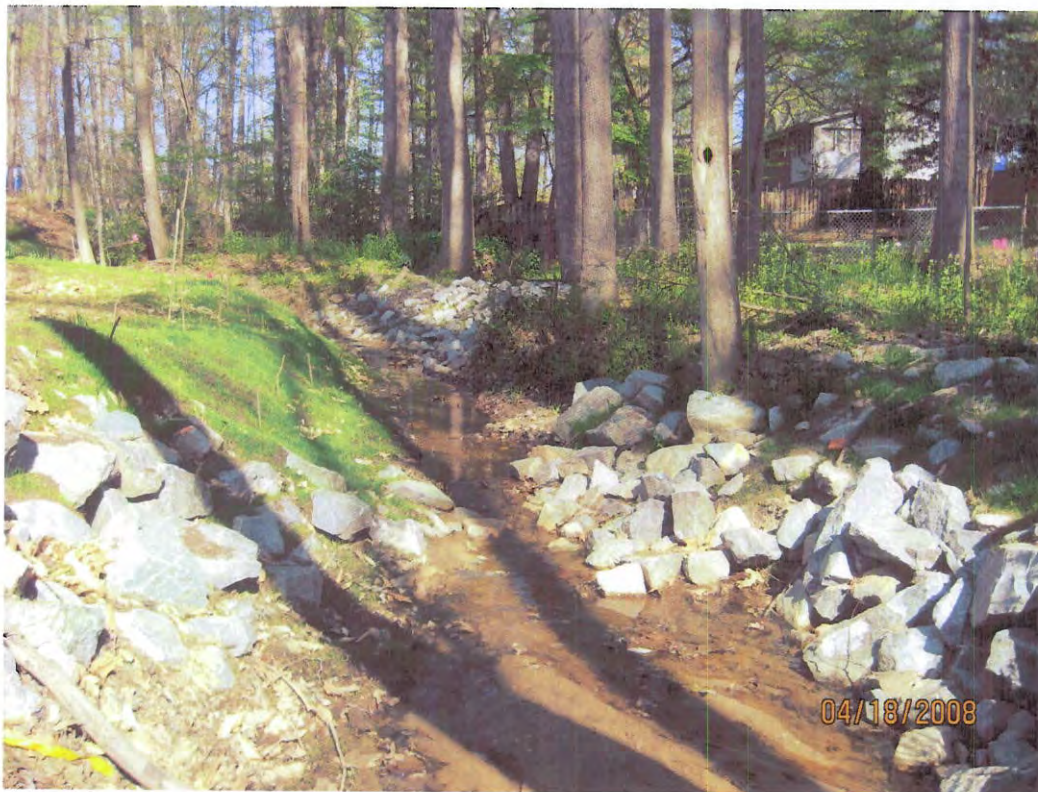
AFTER - Location of #1 rock weir (photo zone 1)

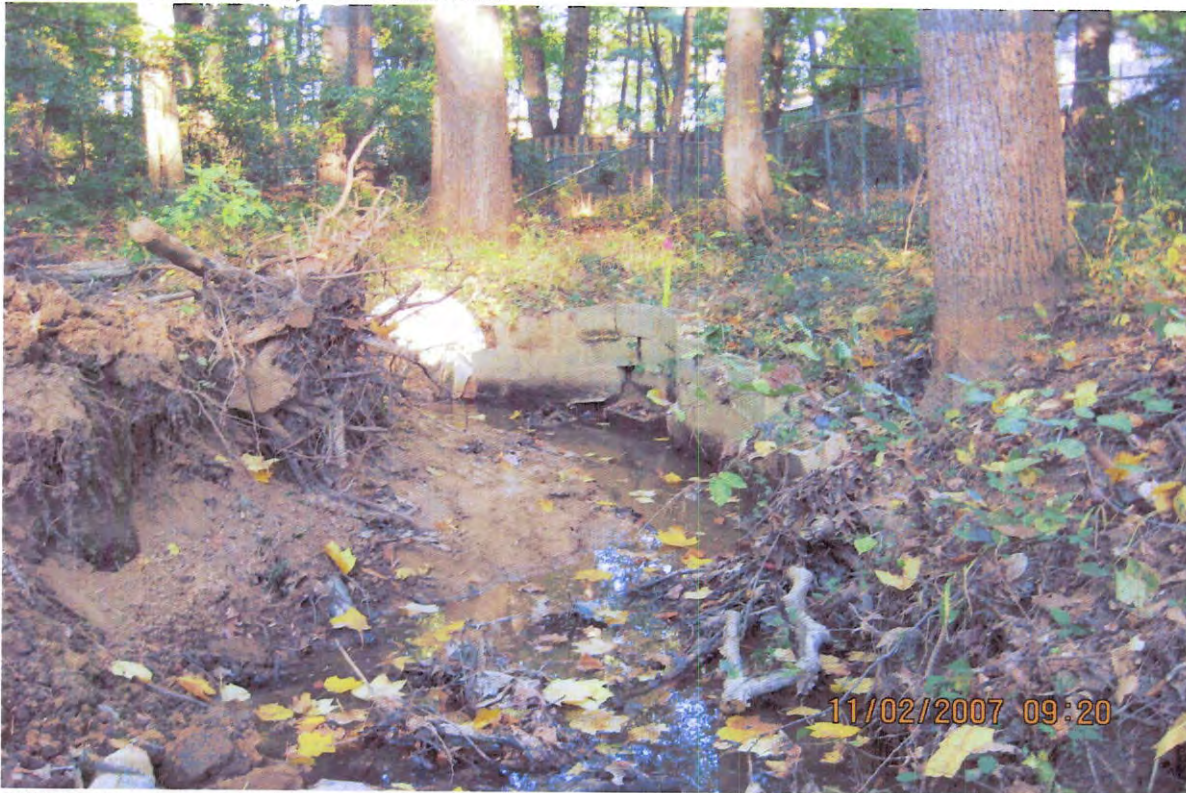
BEFORE - Location #1, need to cut and fill of bank, add stone and mulch treatment to bank .

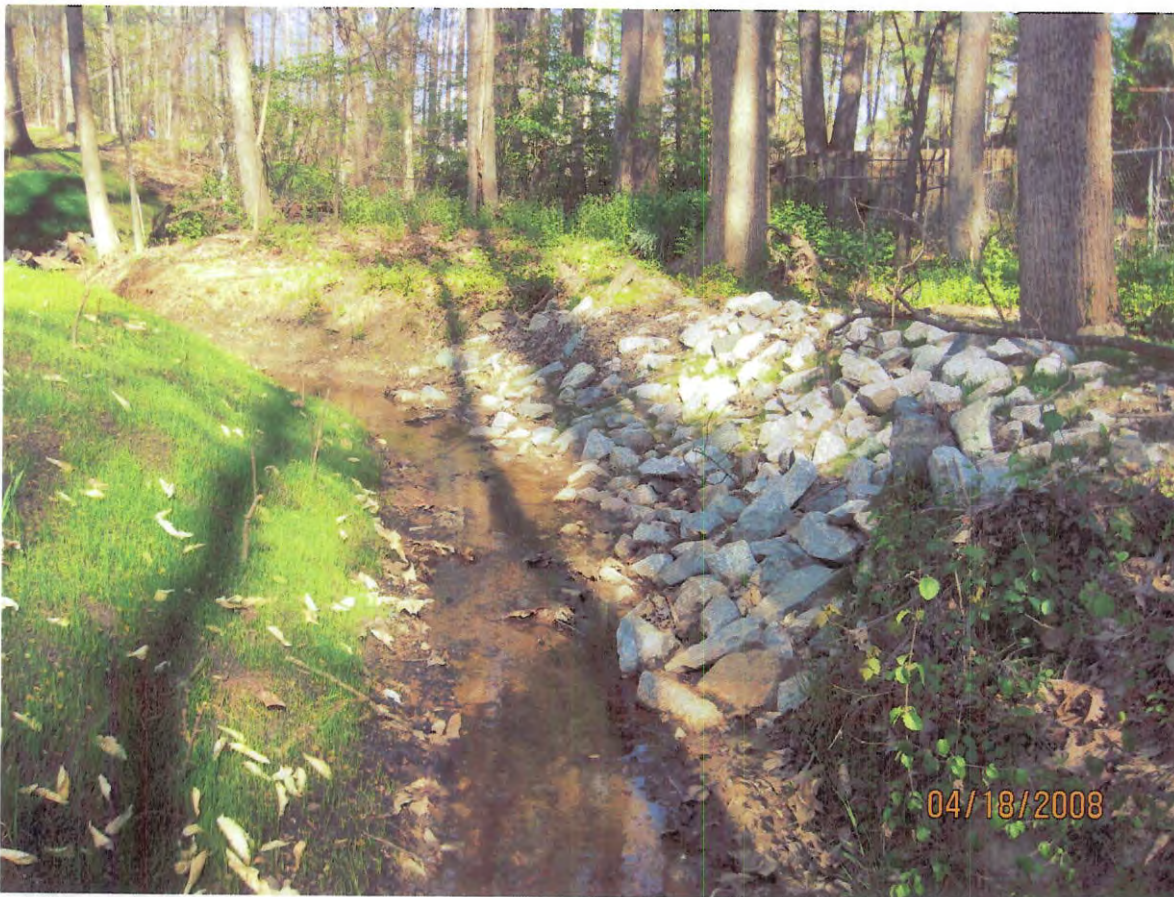
AFTER - Location #1, cut and fill of banks and stone and mulch bank treatment..

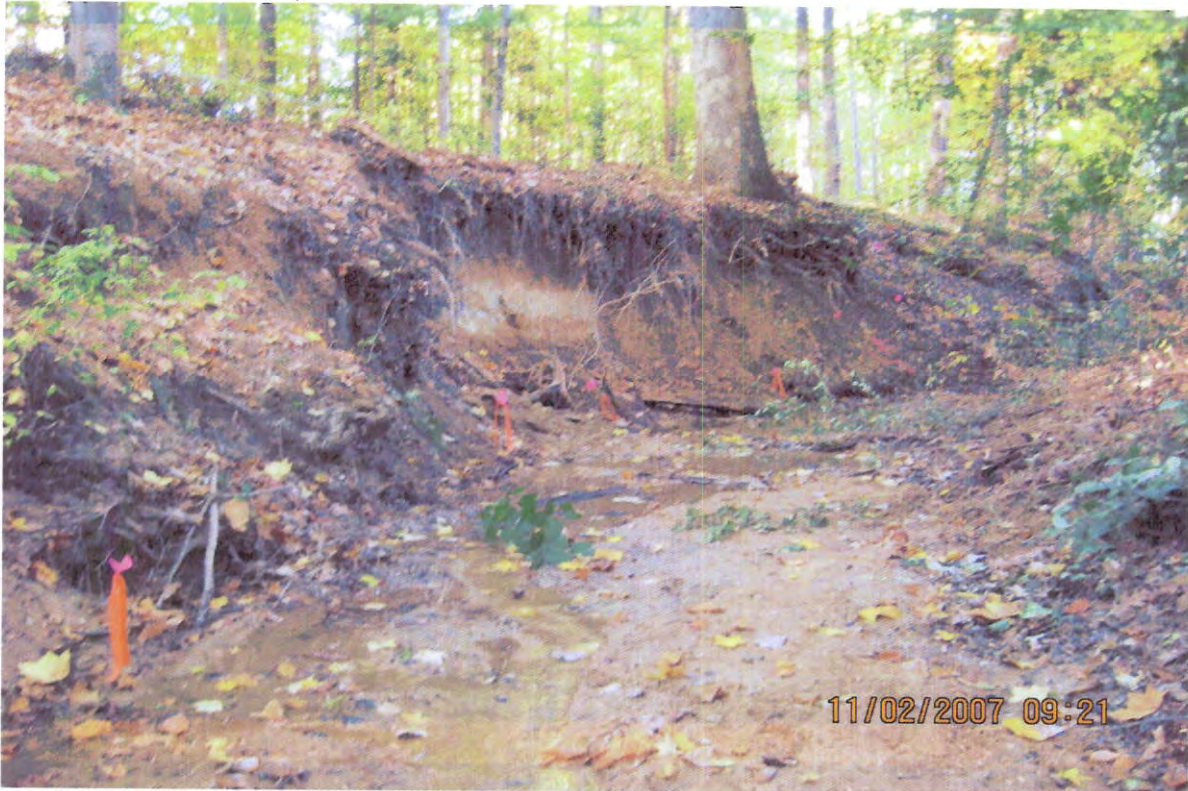
BEFORE – (Photo Zone 2) Future location of #2, rock weir and left bank stabilization.

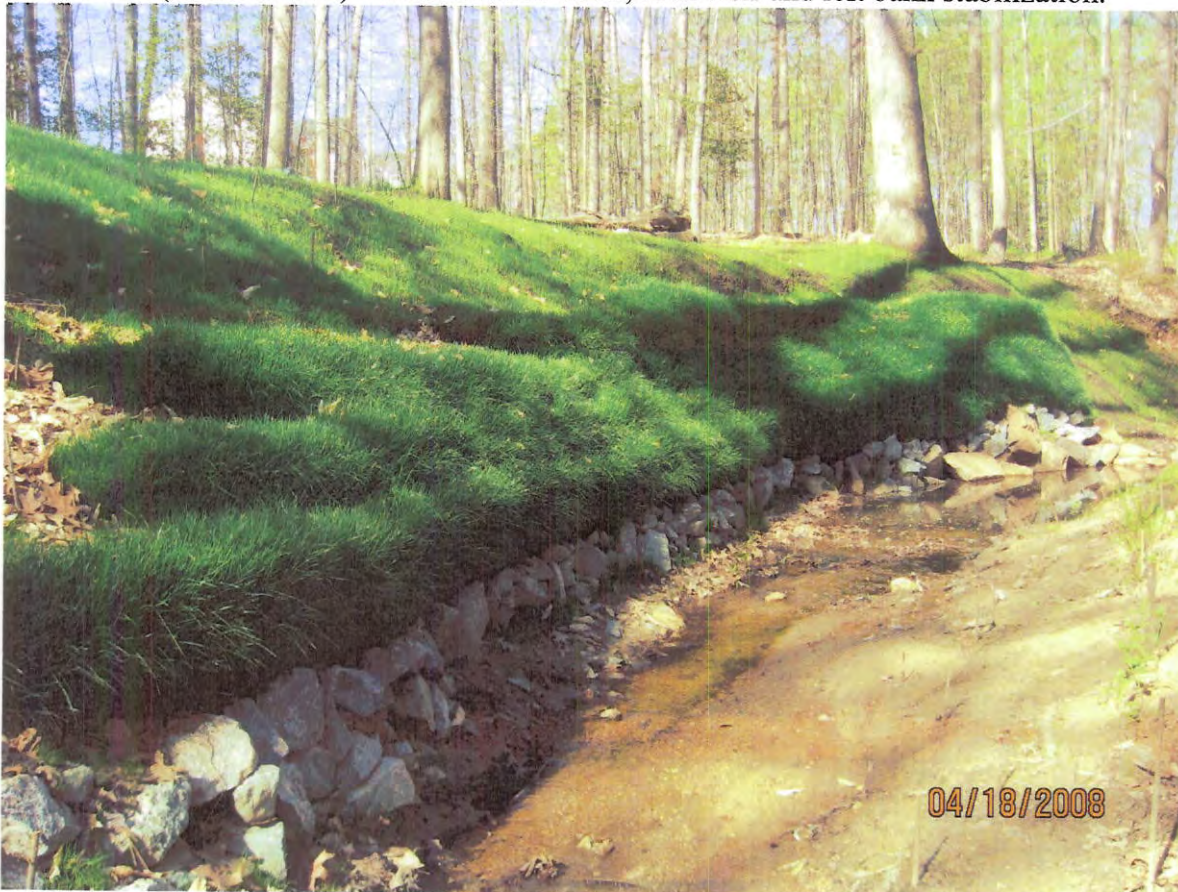
AFTER – (photo zone2) Location of structure #2, rock weir and left bank stabilization with stone and filter socks.

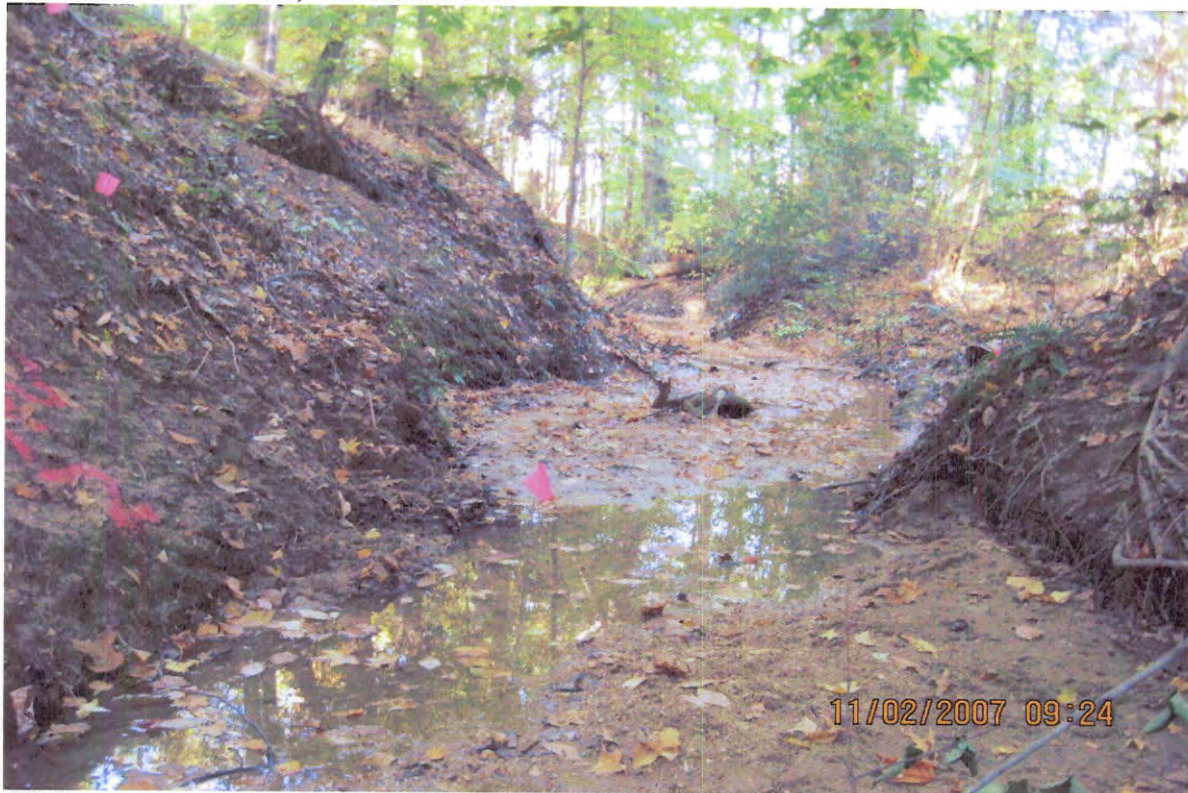
BEFORE – (Photo Zone 2) left bank stabilization and right bank stabilization (below weir #2).

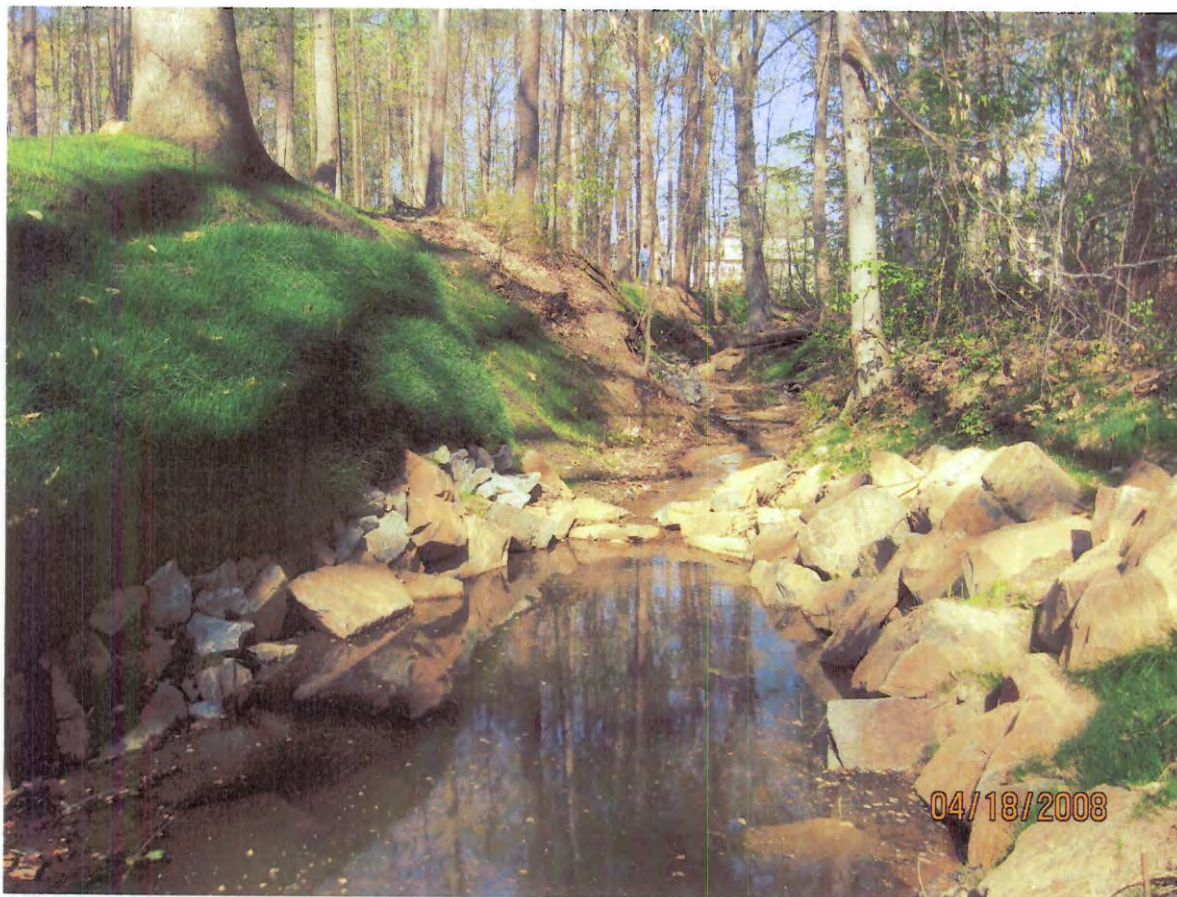
AFTER - left bank filtrex stabilization and right bank rock stabilization (below weir #2).

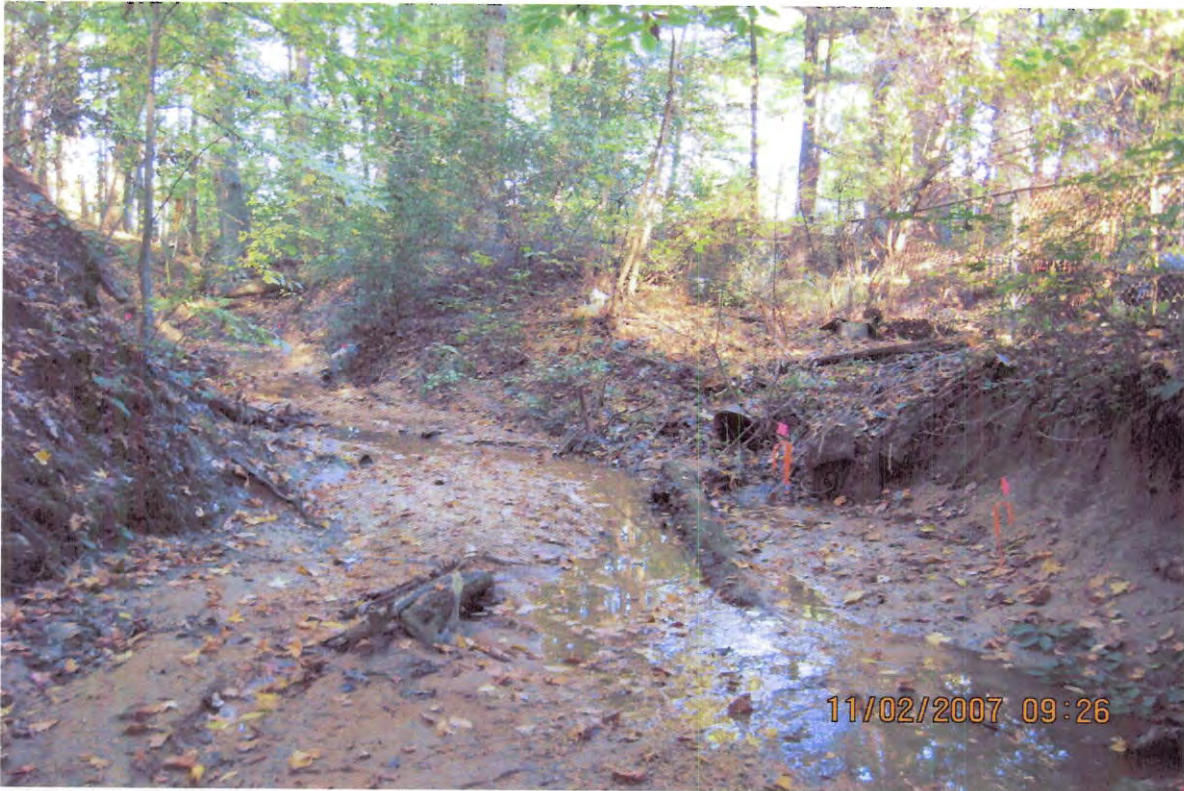
BEFORE – Right bank needs stone toe and bank stabilization.

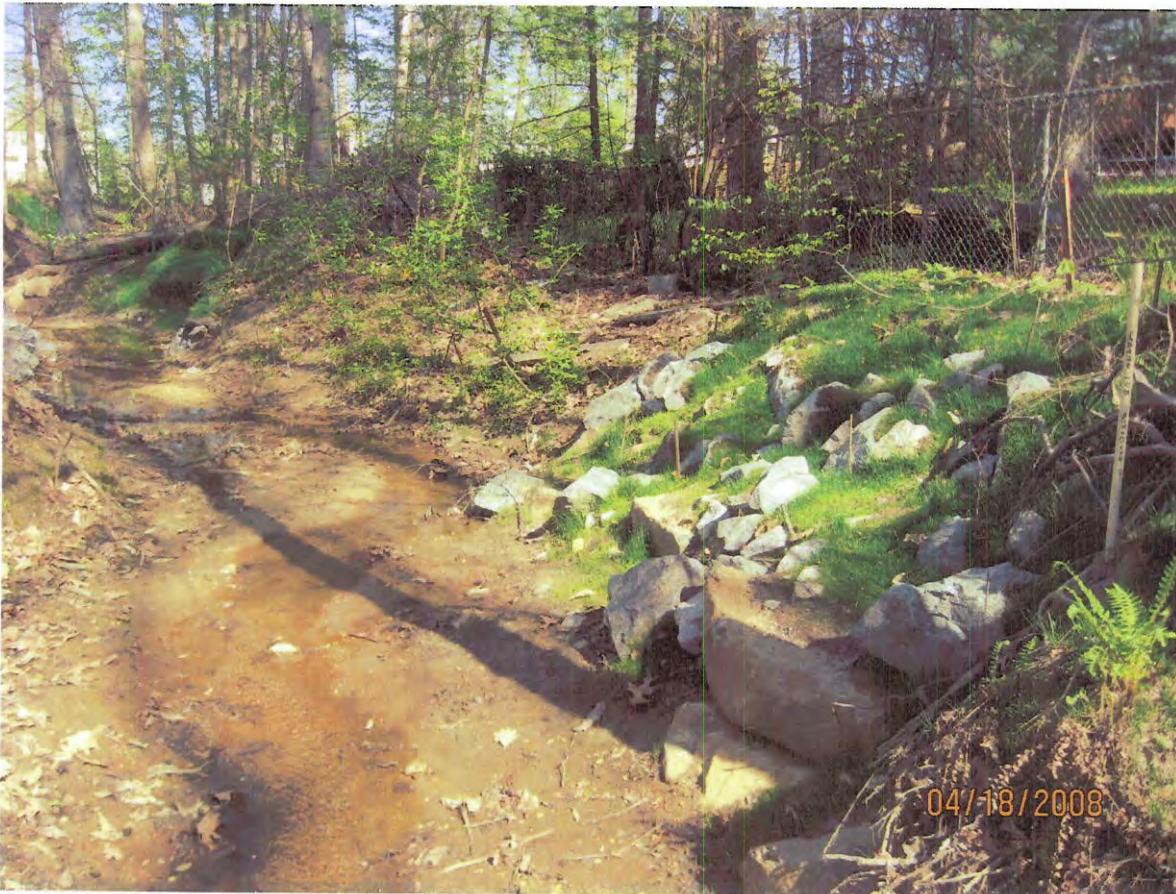
AFTER - Location #4, stone toe and bank stabilization.

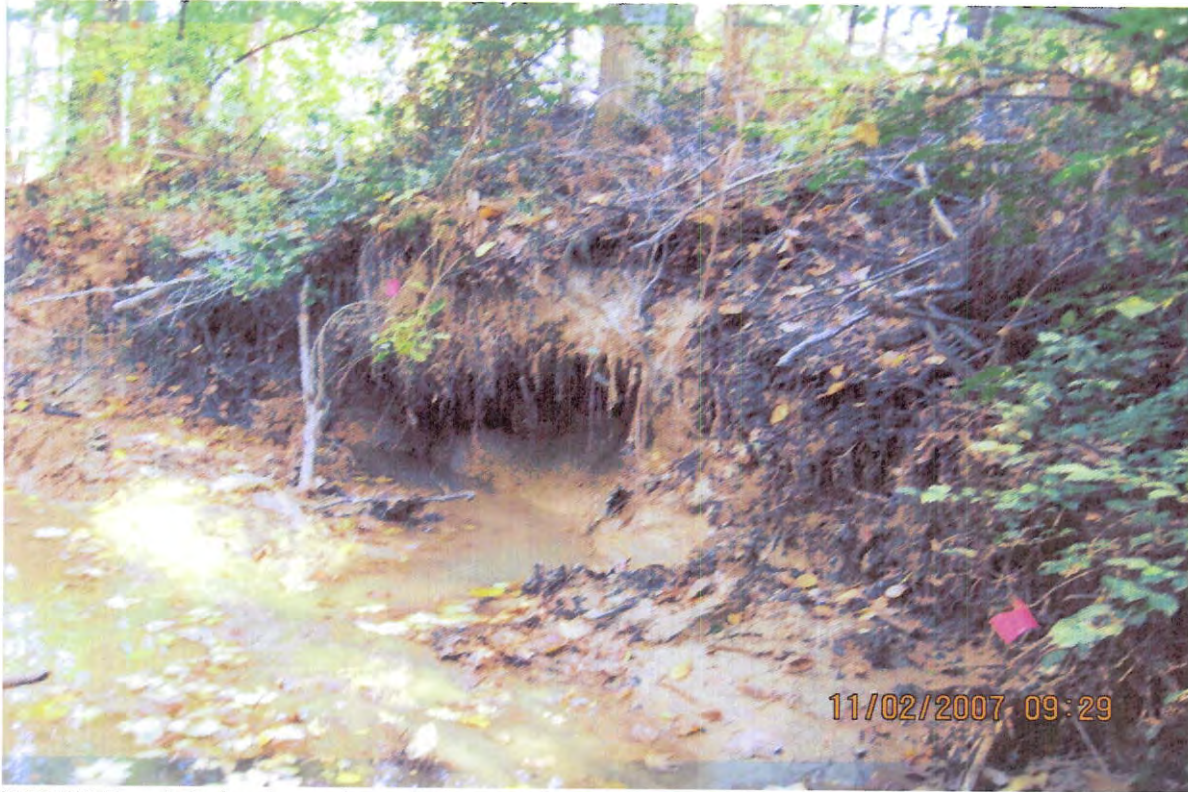
BEFORE – right bank needs rock toe and filtrex sox stabilization.

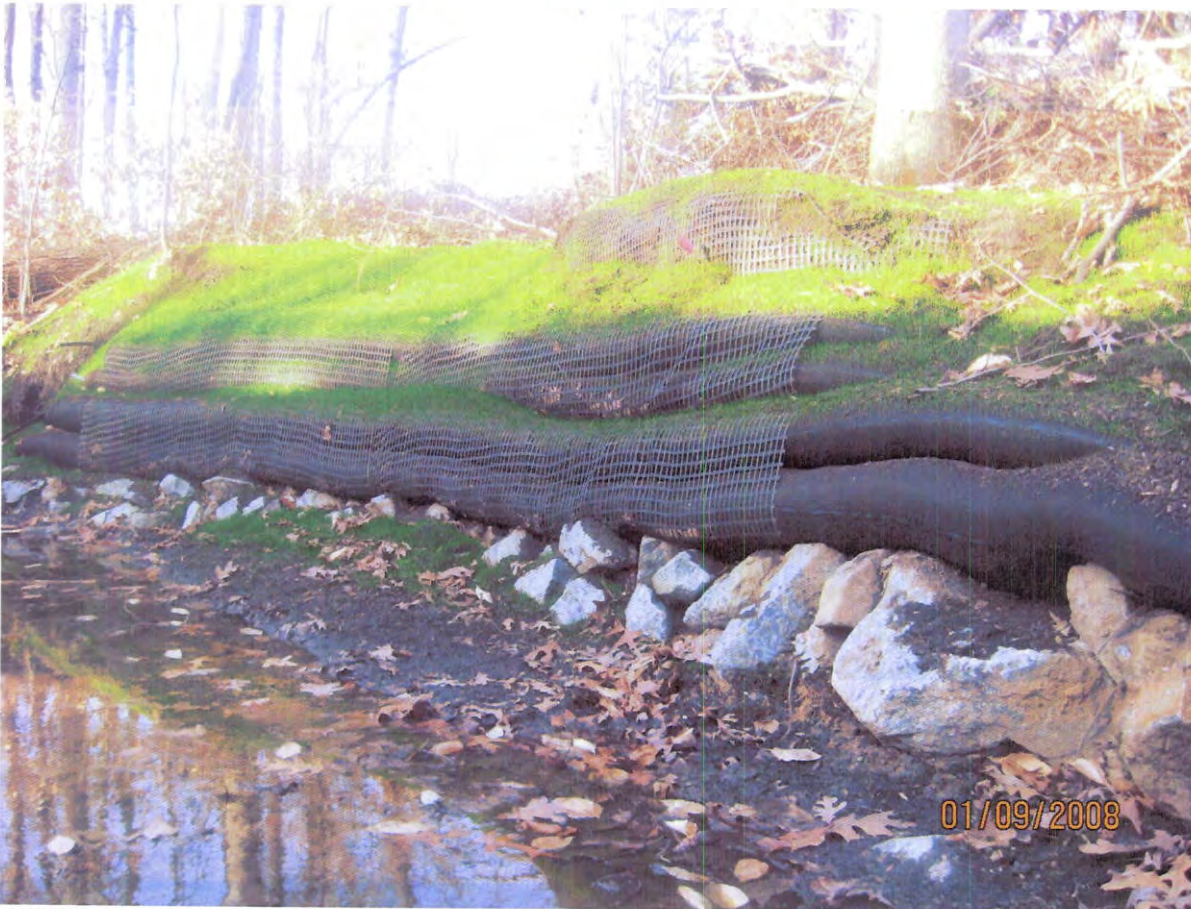
AFTER - rock toe treatment filtrex bank stabilization.

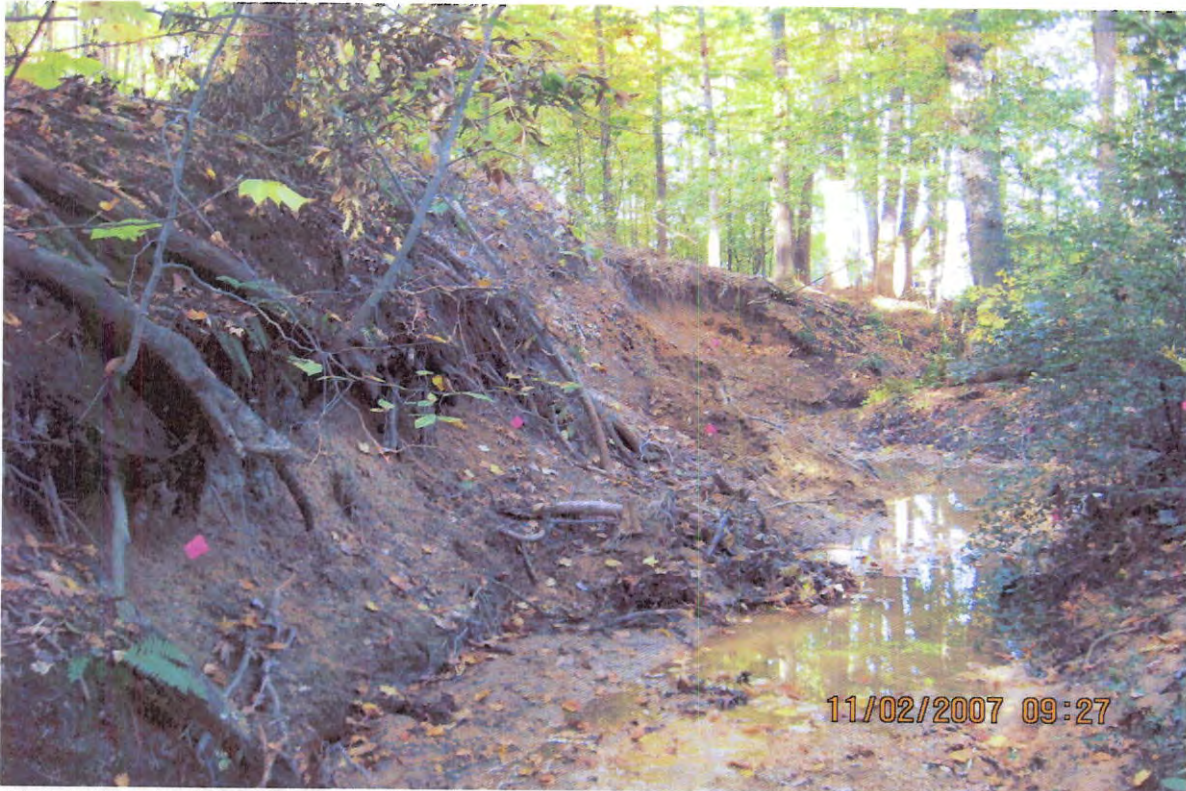
BEFORE – Left and bank needs stone toe filter sock and compost tea bank stabilization.

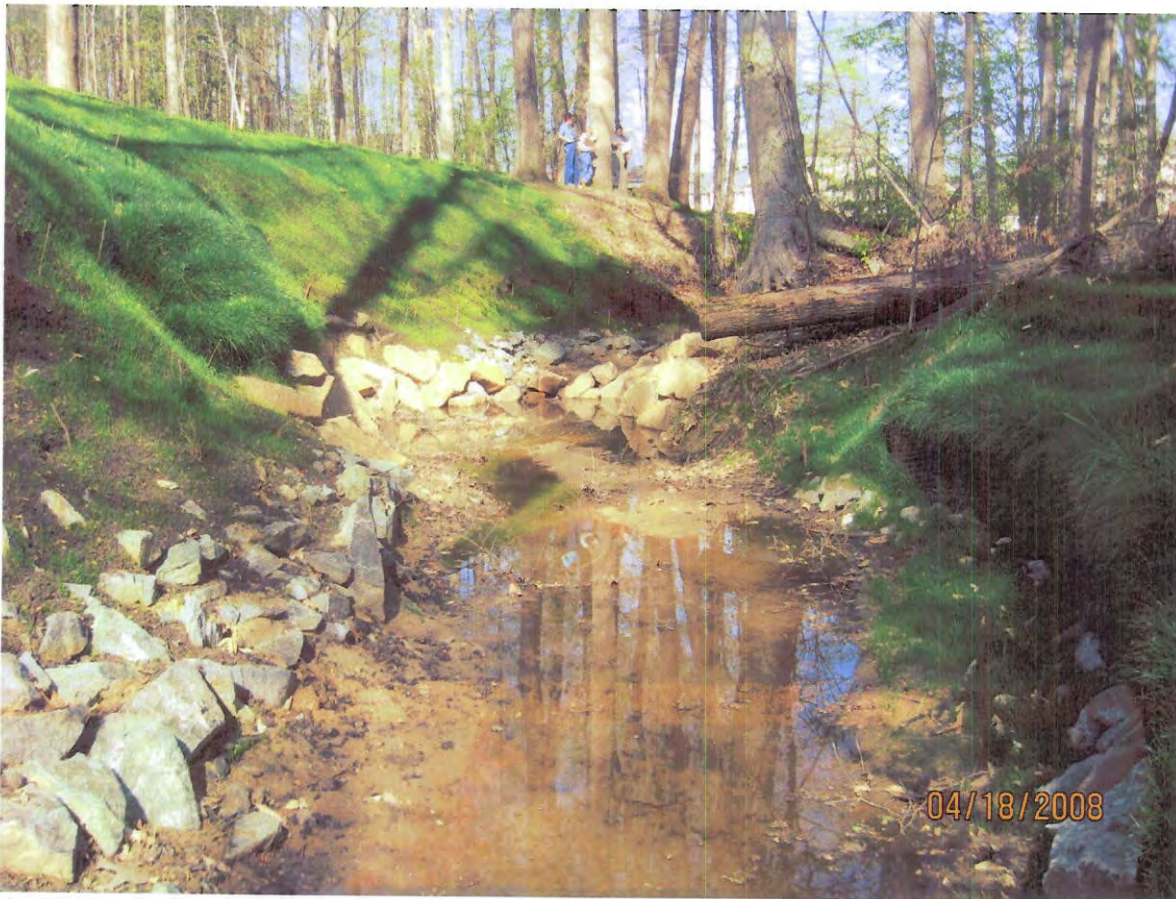
AFTER – Left and right bank stabilization with stone toe, filter sock and compost tea.

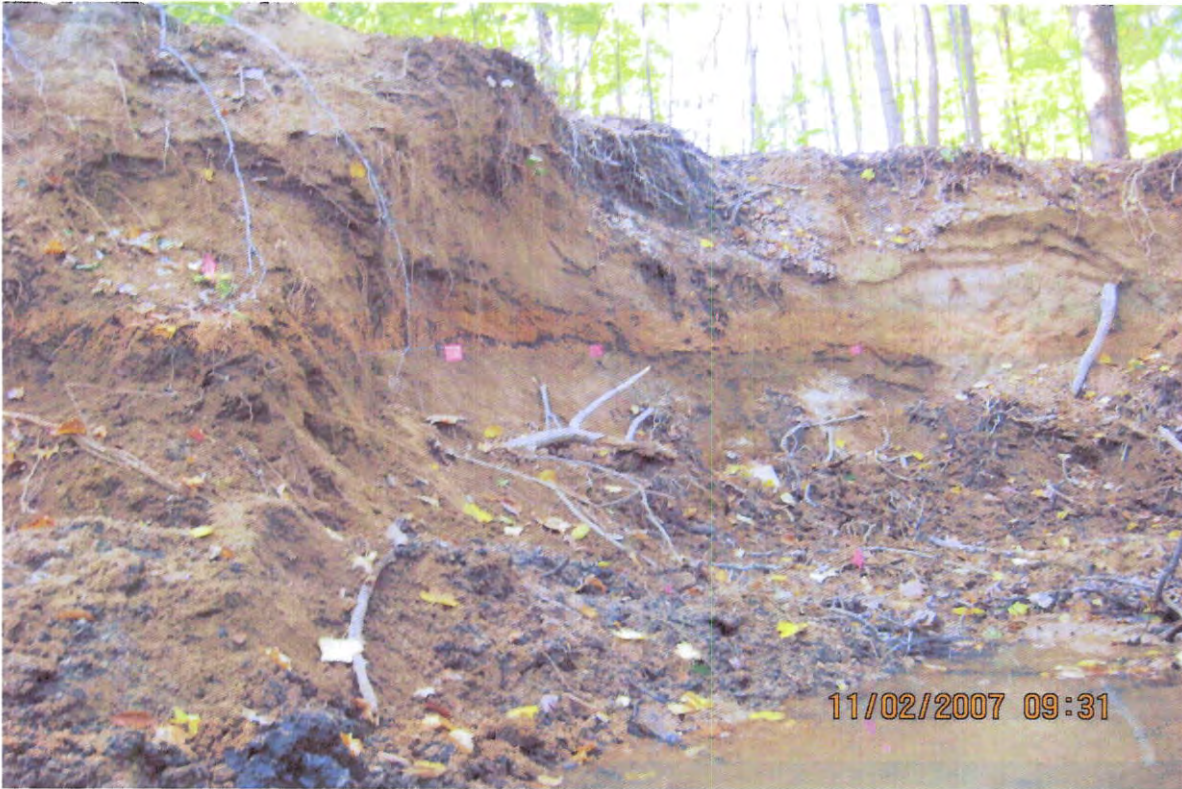
BEFORE – Eroded left stream bank before stabilization.

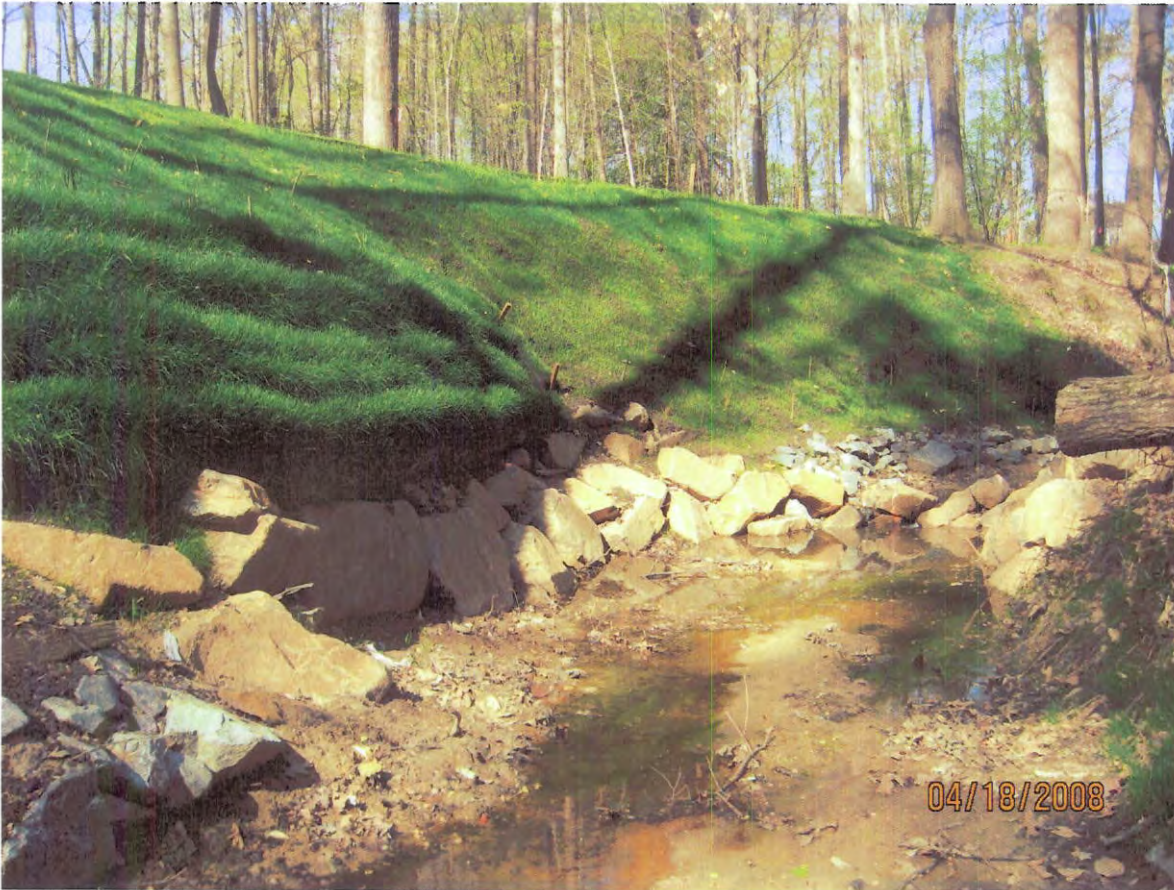
AFTER – filtrex sox supported by rock toe structure and bank stabilization with compost tea.

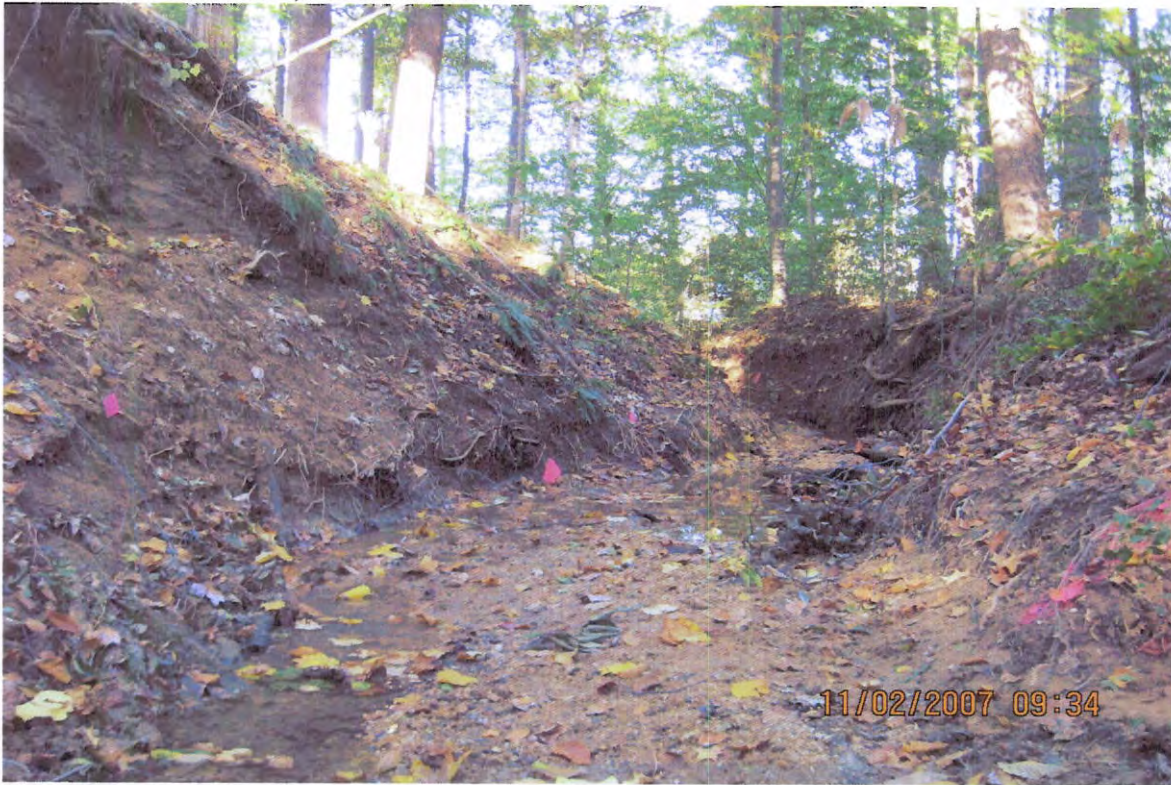
BEFORE - Location for weir #3

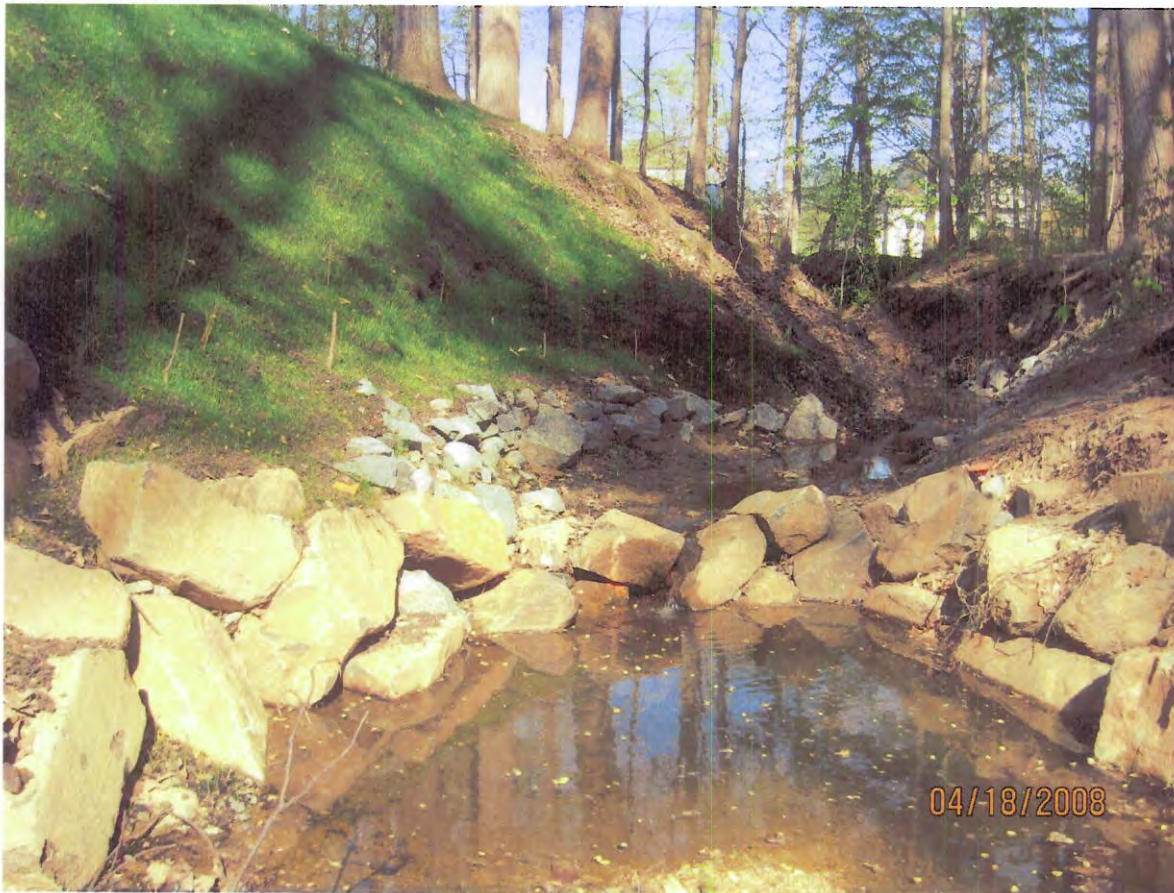
AFTER - Location for rock weir #3 which tied into the sill created for bank stabilization.

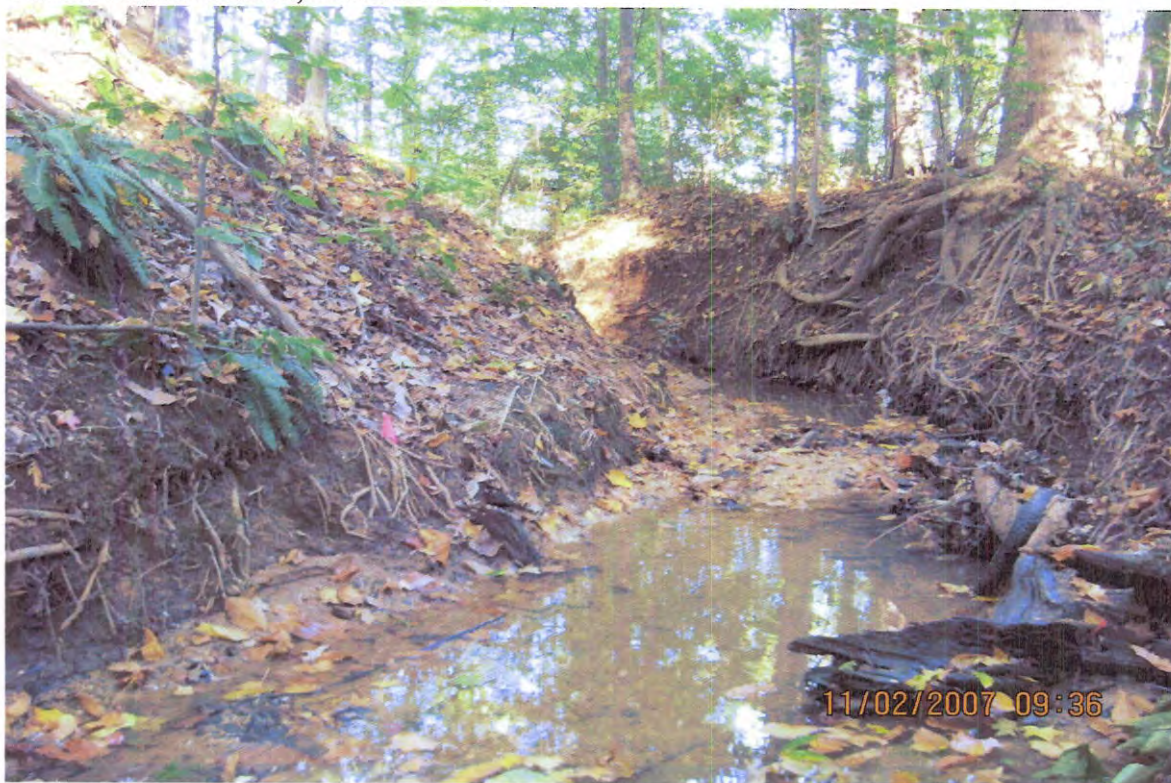
BEFORE - bank needs stabilization upstream from weir #3.

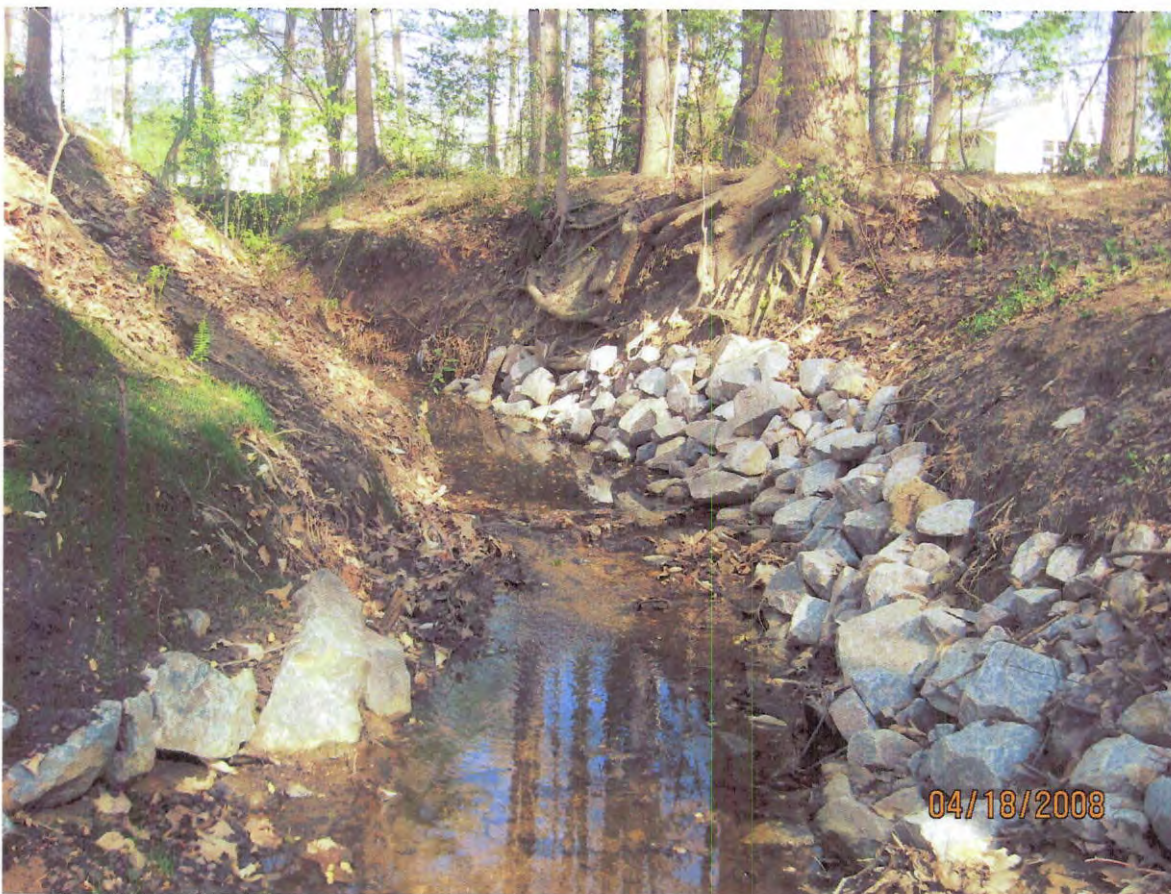
AFTER - bank stabilization upstream from structure 3.

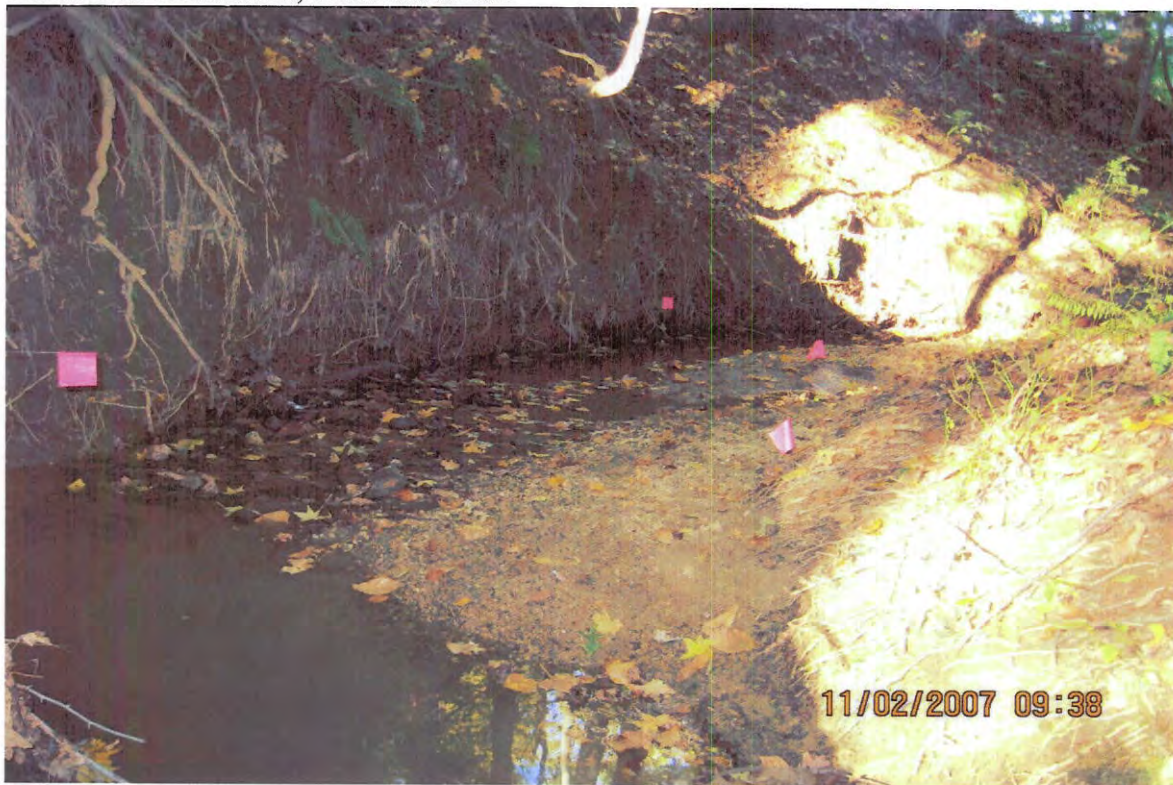
BEFORE - Location to excavate channel bar near right bank and stabilize the left stream bank.

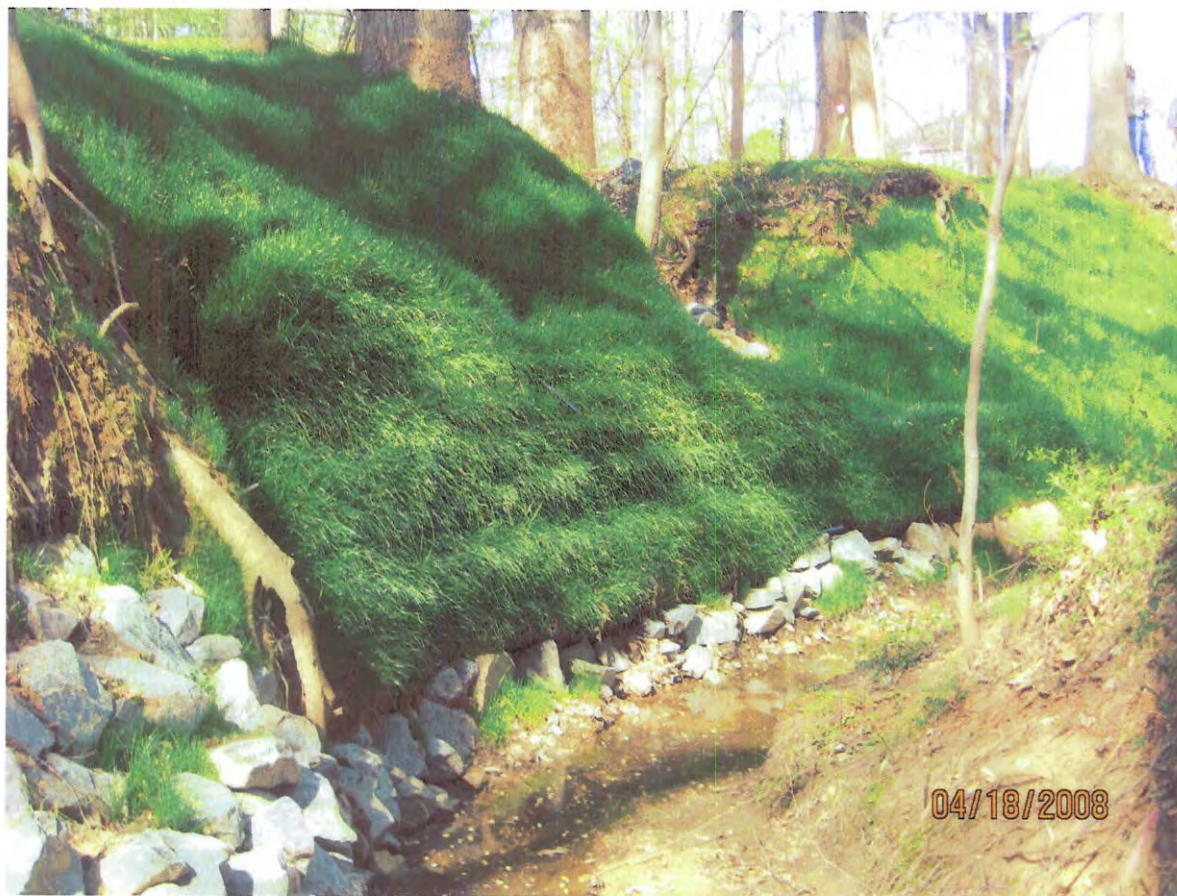
AFTER - Stabilized bank and widen channel

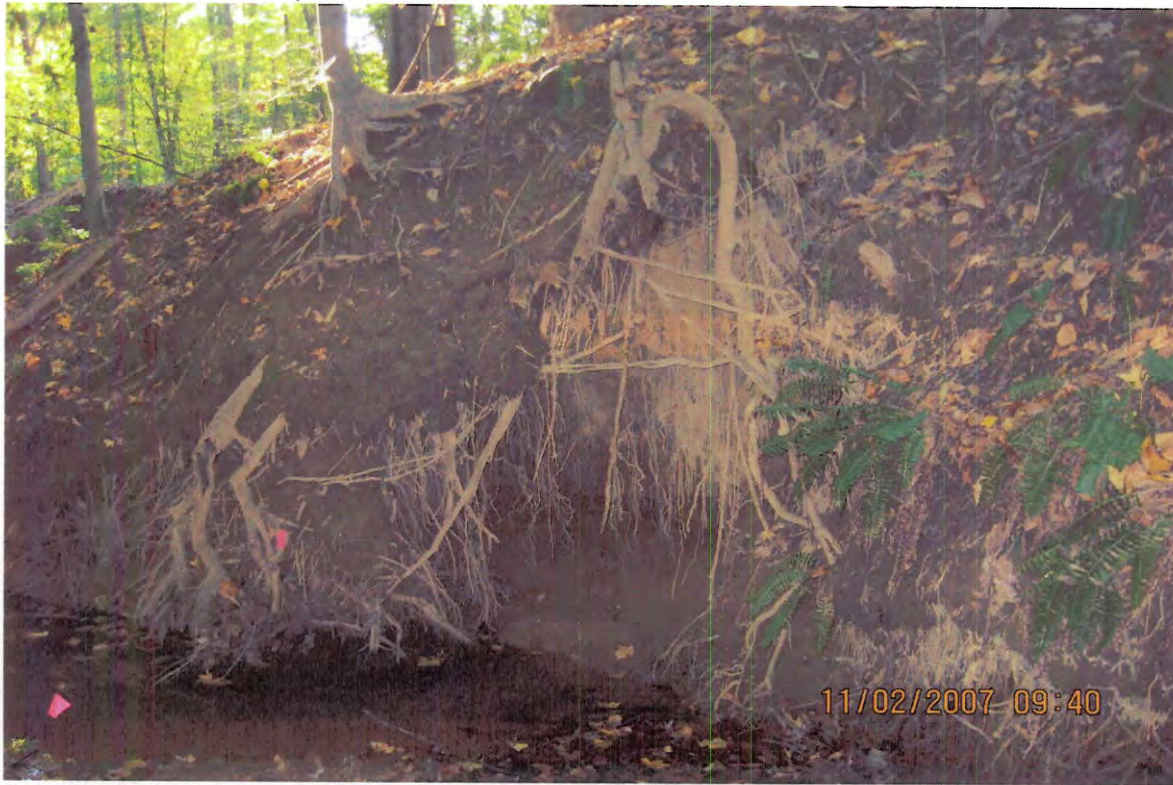
BEFORE – Need to stabilize bank with toe stone, filtrex sox and backfill.
