Upper Cabin Run Rehabilitation Project

DATE: April 18, 2008

SUBJECT: **PHOTO DOCUMENTATION OF CABIN RUN STREAM PROJECT**
(BEFORE AND AFTER DOCUMENTATION)

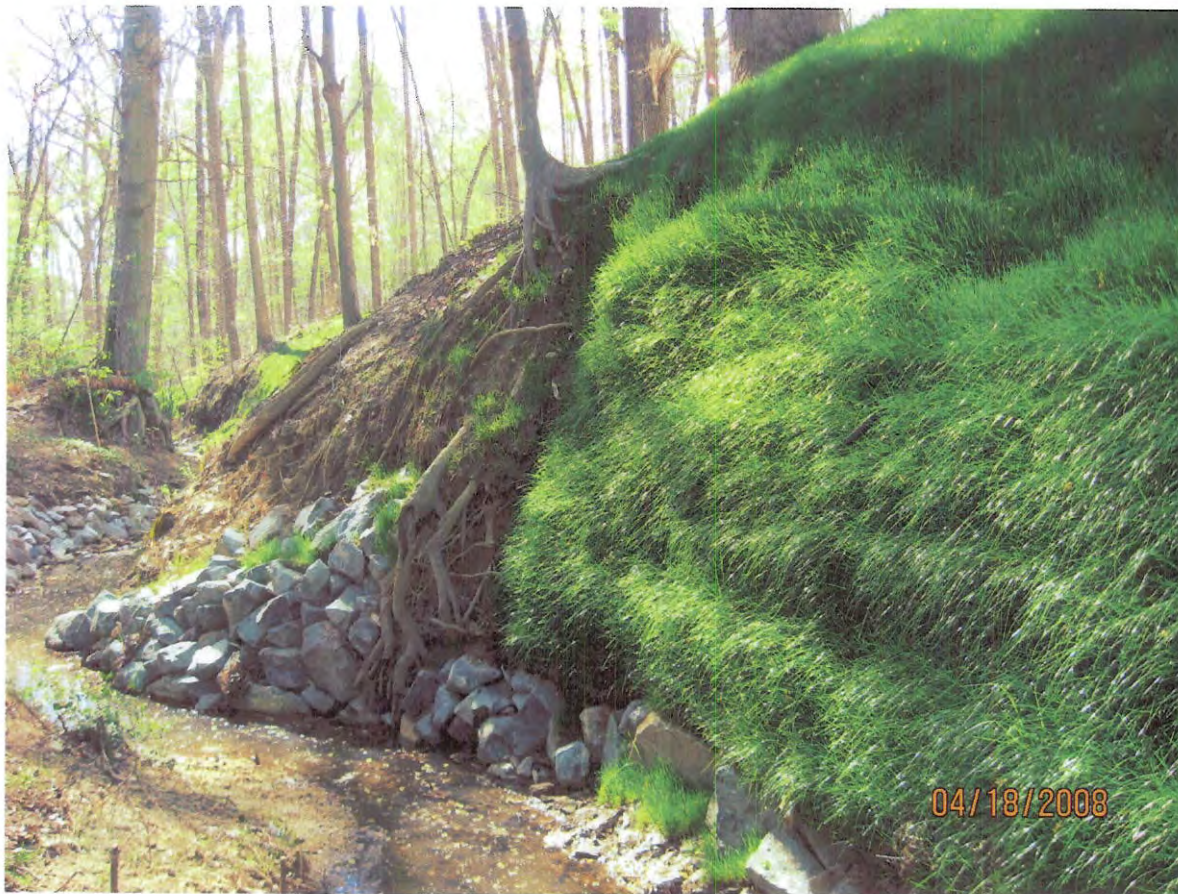
AFTER - Location #7, stabilize bank with toe stone, filtrex sox and backfill.

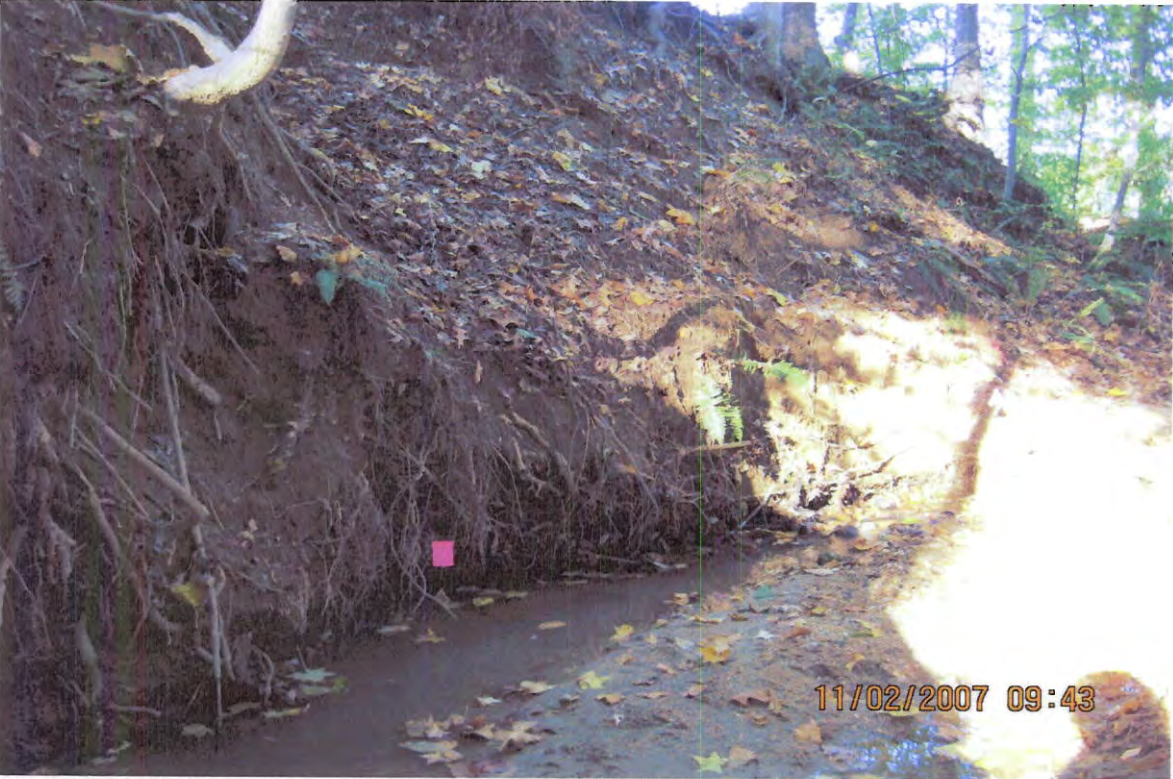
BEFORE - Need to create a stone toe and cut slope to terrace to support filterxx bank stabilization.

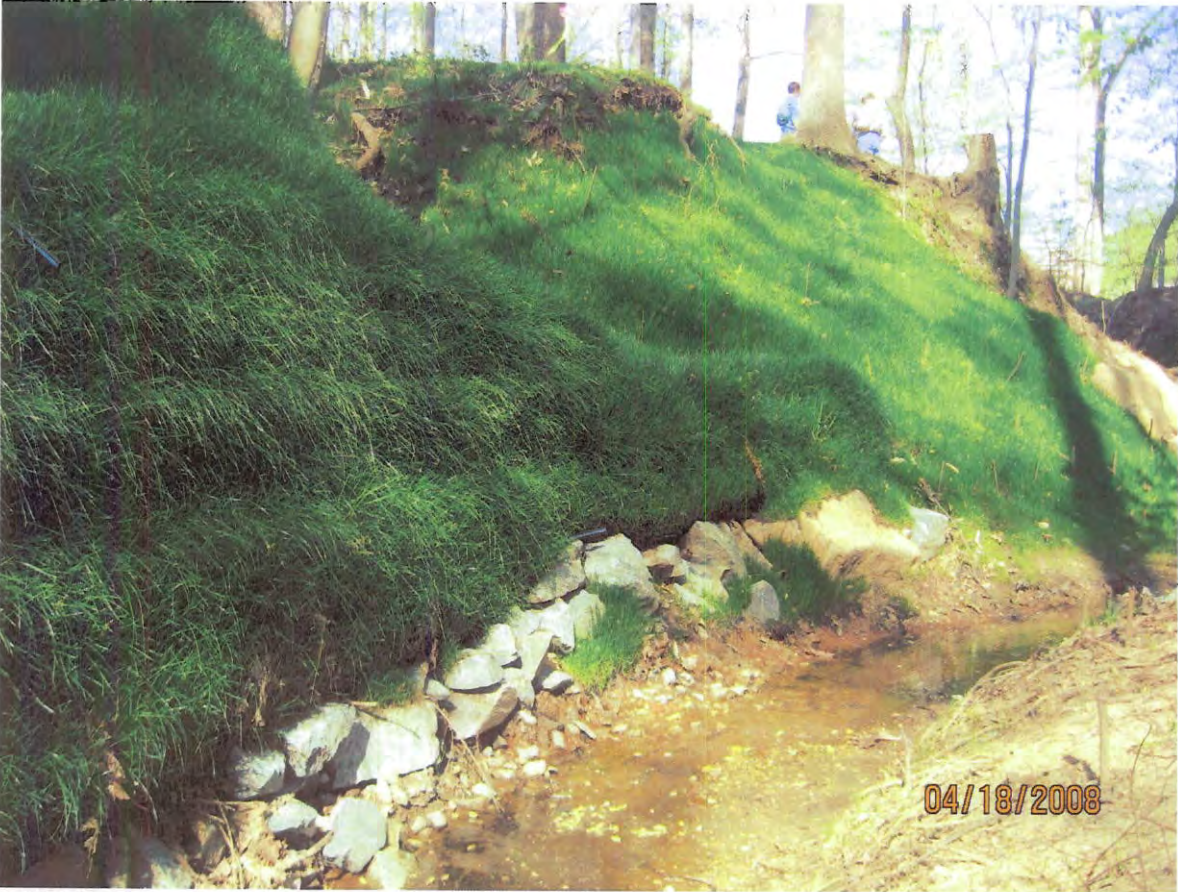
AFTER - Location #8, Terrace slope, filterxx bank stabilization, stone toe.

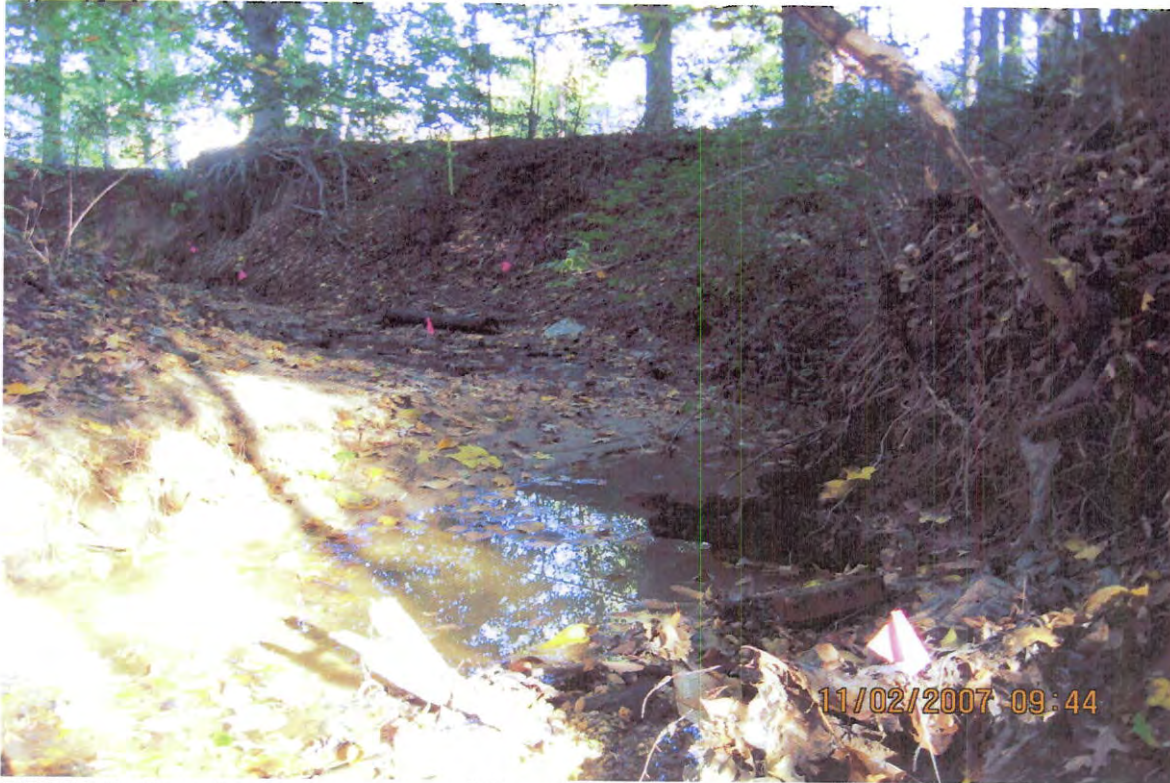
BEFORE - Location to excavate sand deposition bar, create terrace and stabilize bank.

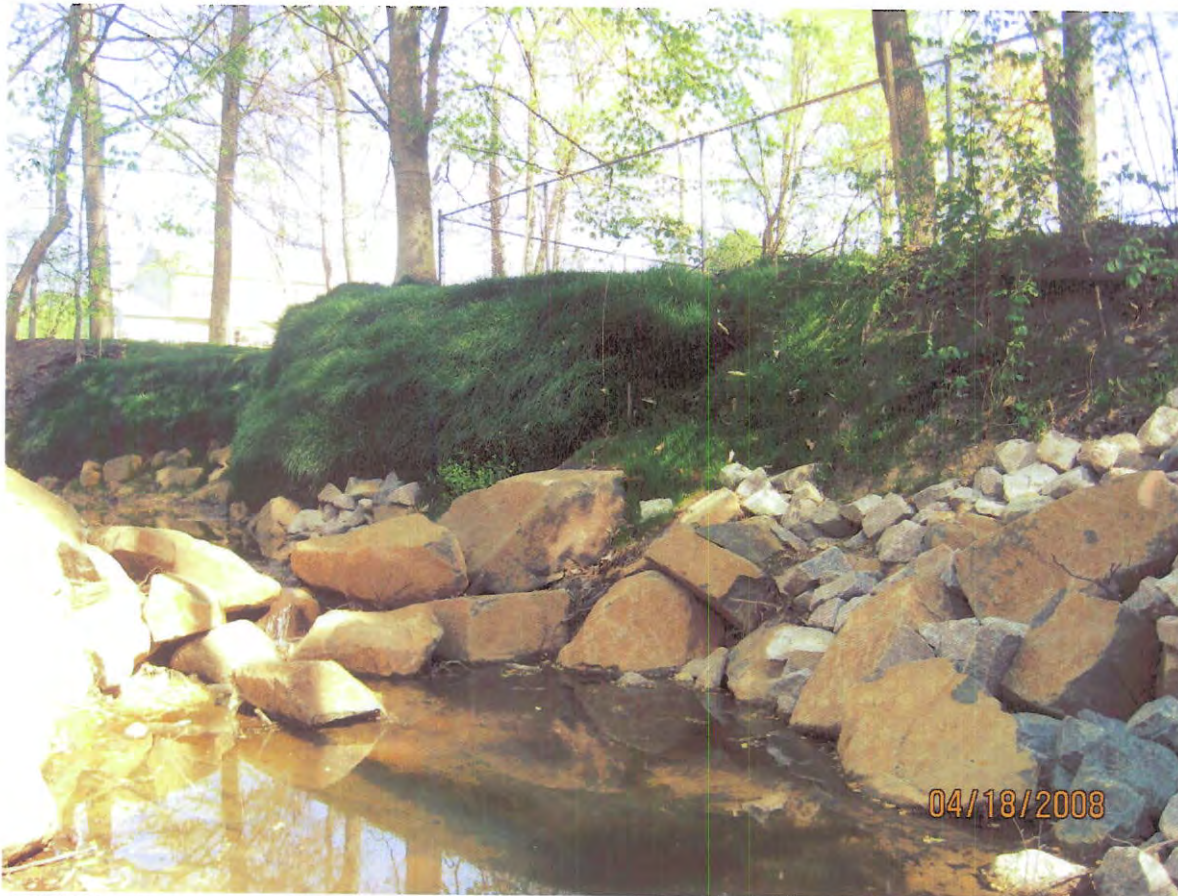
AFTER - Terrace creation and bank stabilization. Near weir #4.

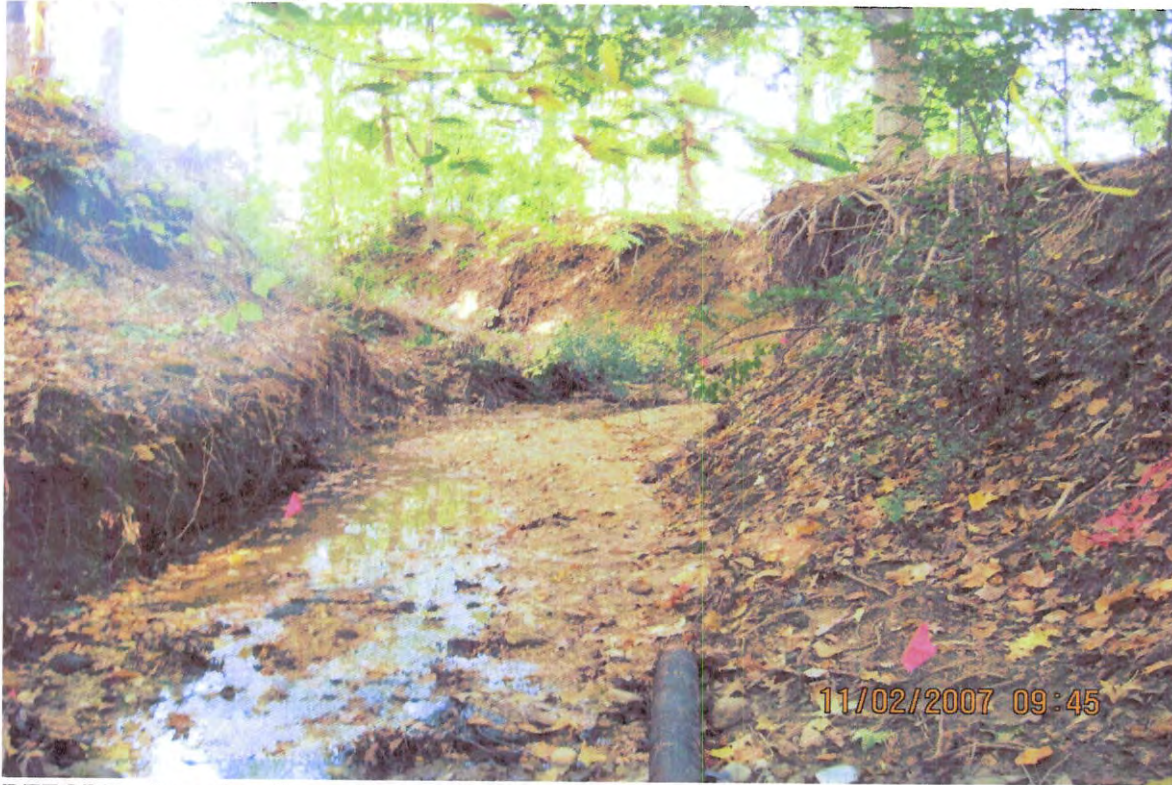
BEFORE - Location for rock weir #4.

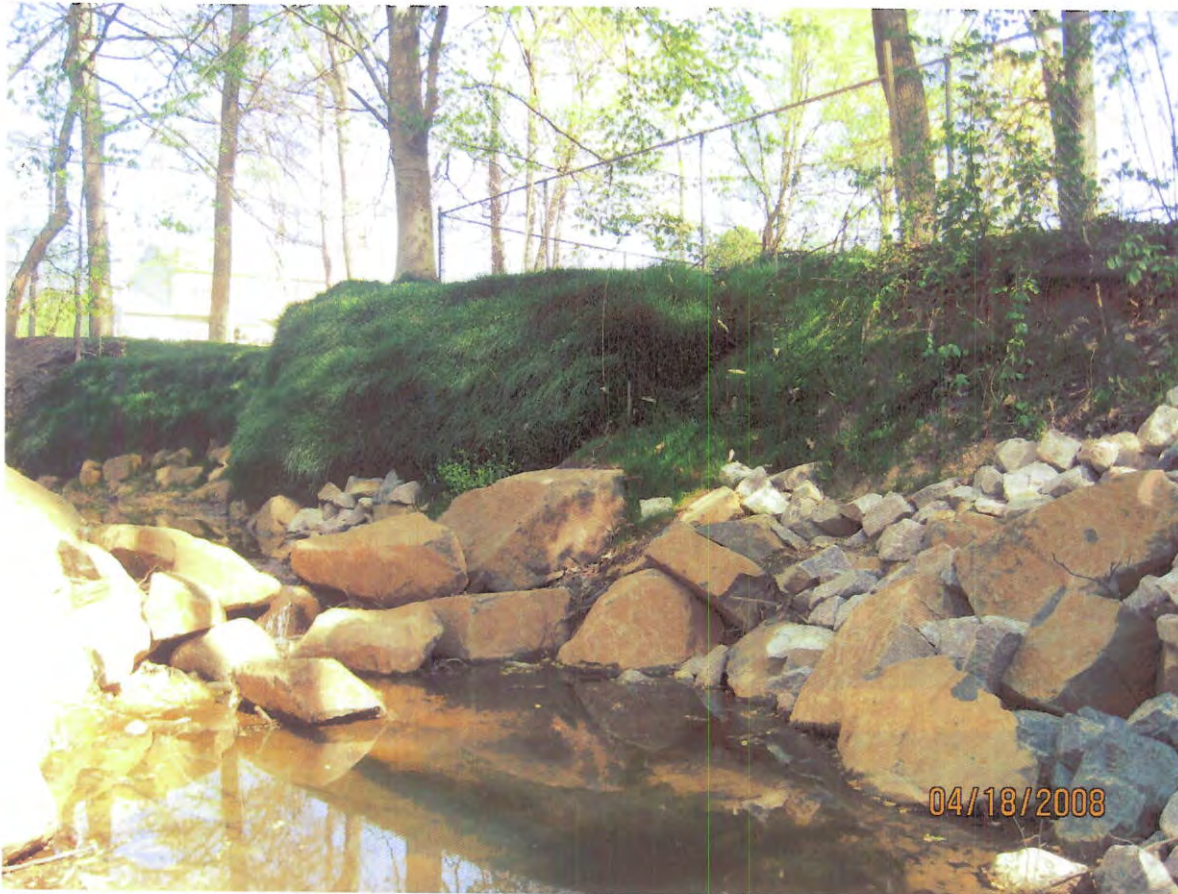
AFTER - Rock Weir #4

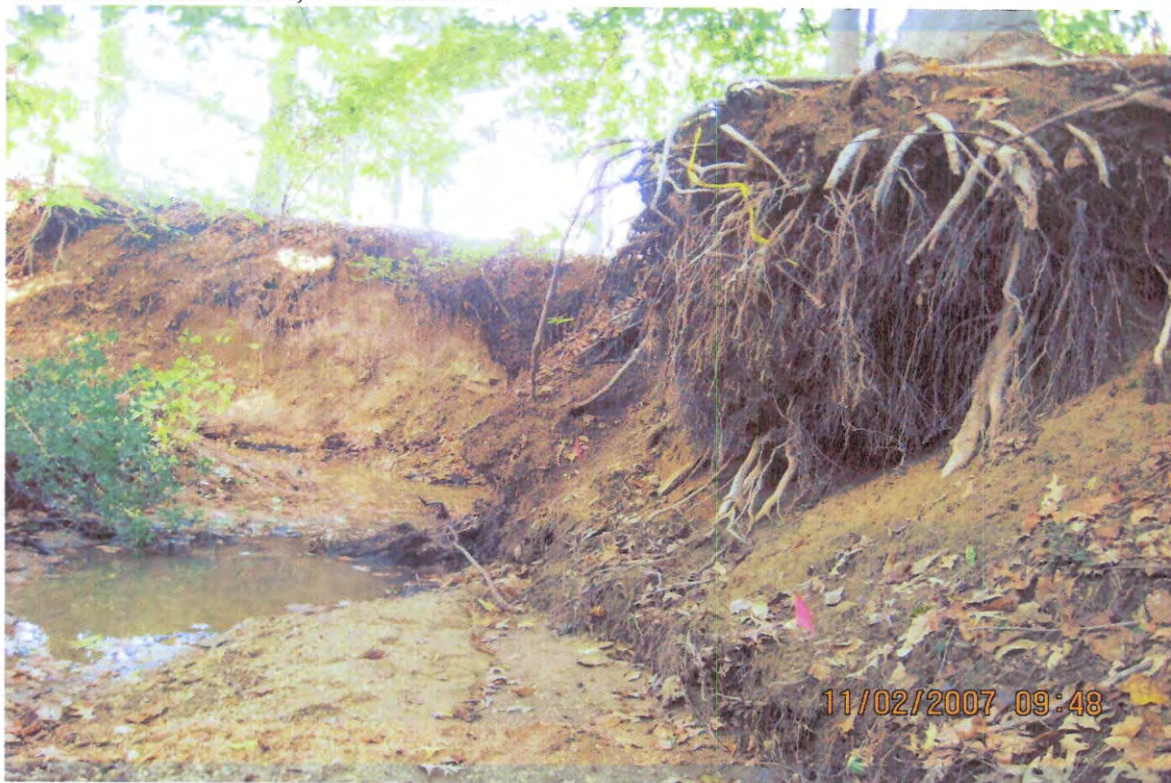
BEFORE –Above weir #4 below beech tree

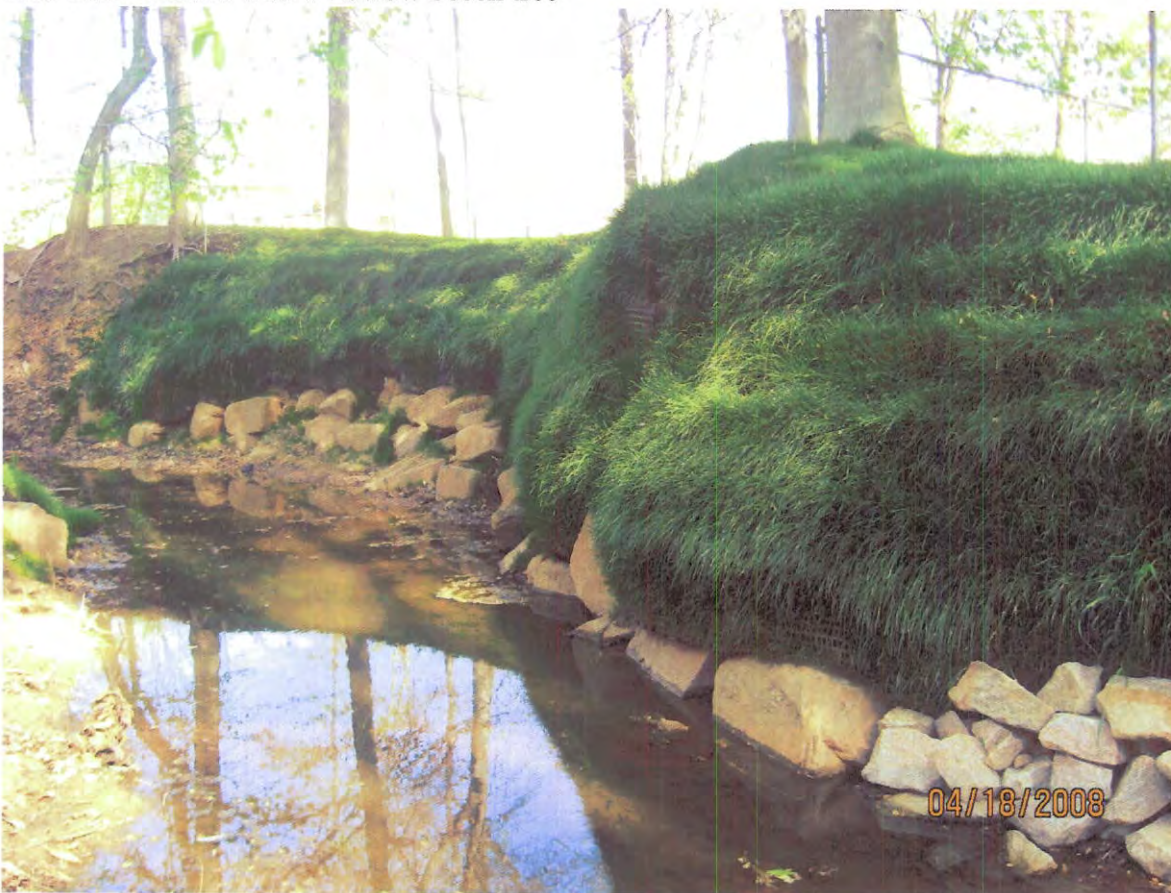
After- above weir #4 create large terrace sill by stone toe, back fill and filter fabric applications.

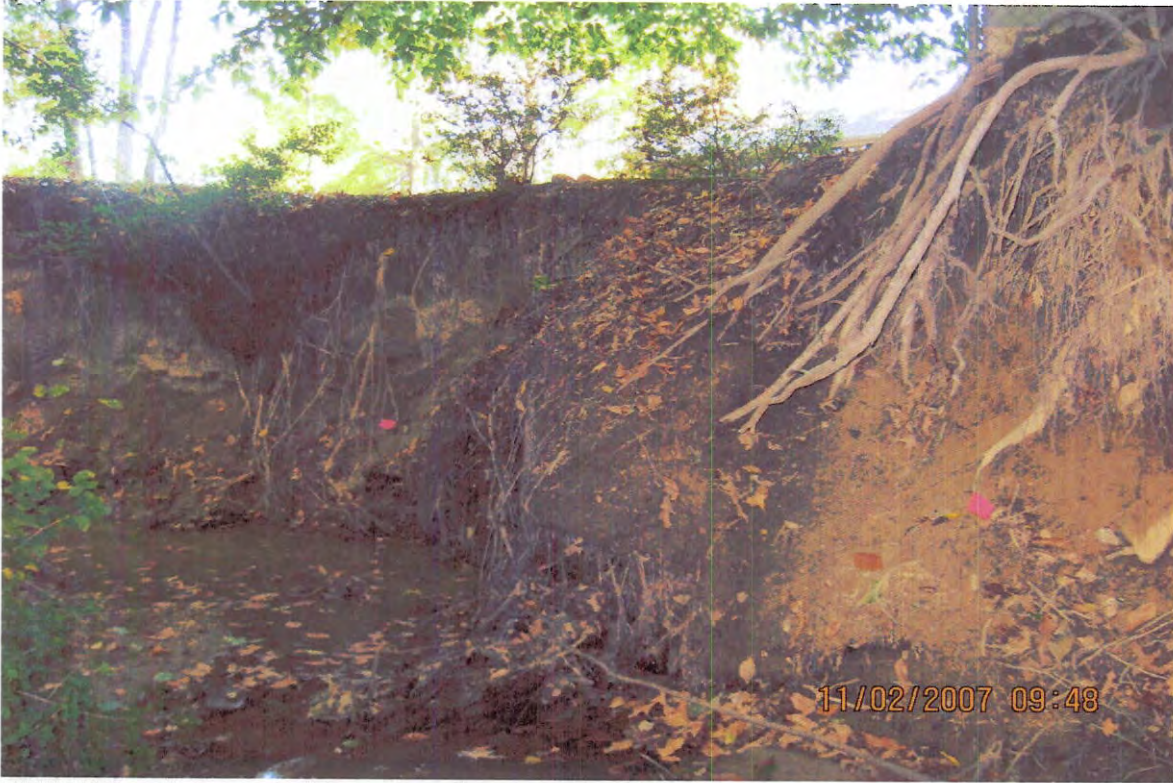
BEFORE – above weir #4 continued.

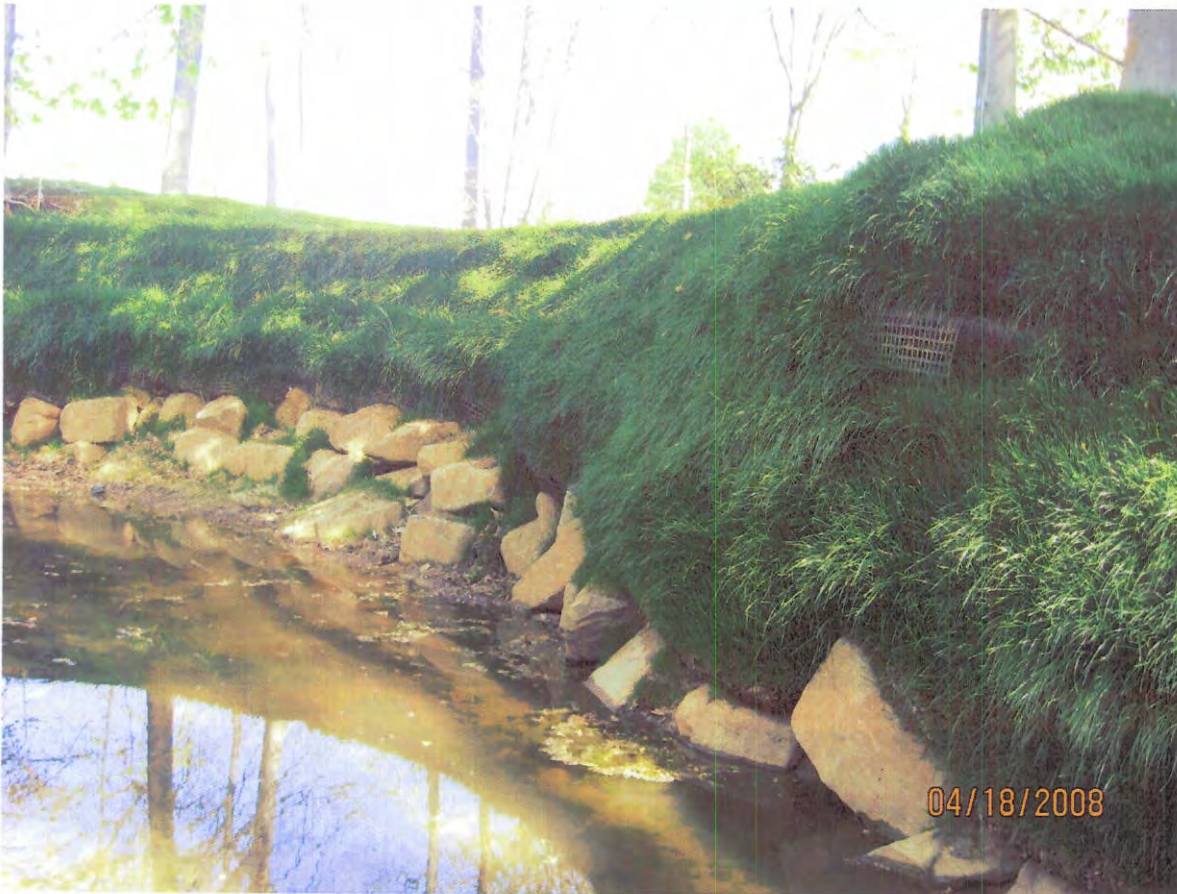
AFTER – above weir #4 continued.

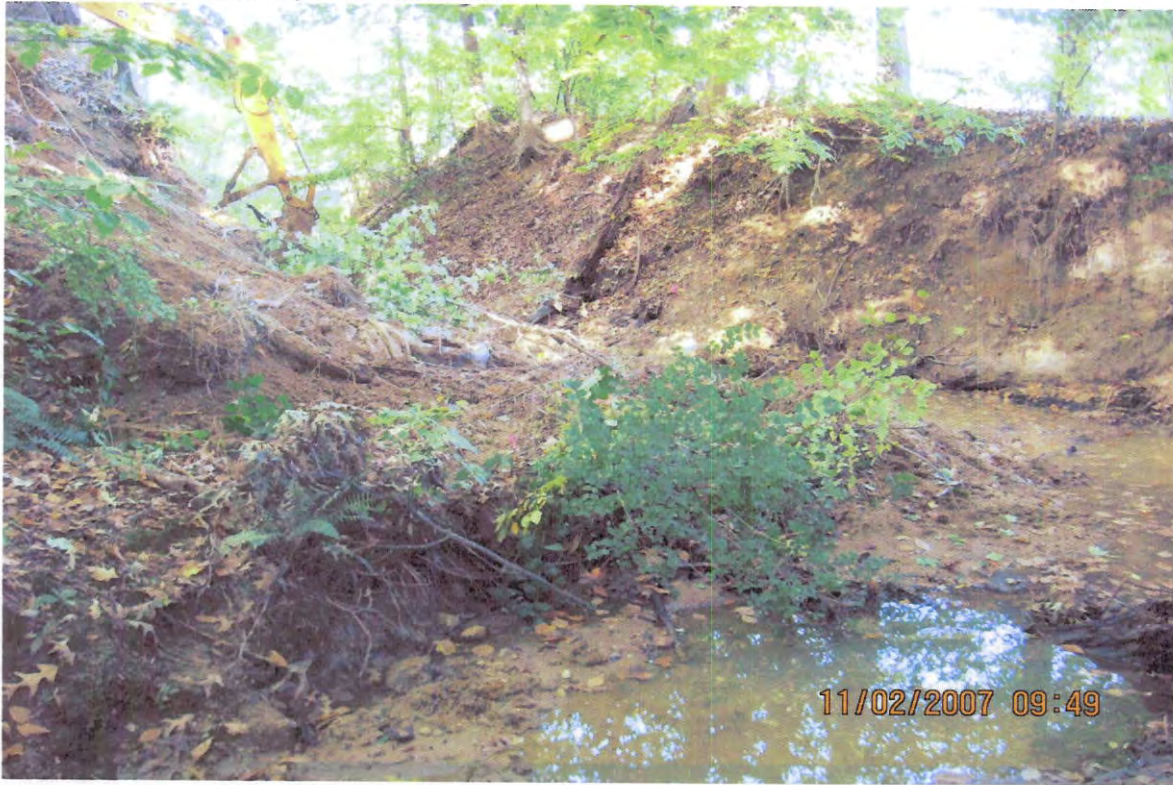
BEFORE - Location of "slope failure area" across right bank created sill and stabilization area.

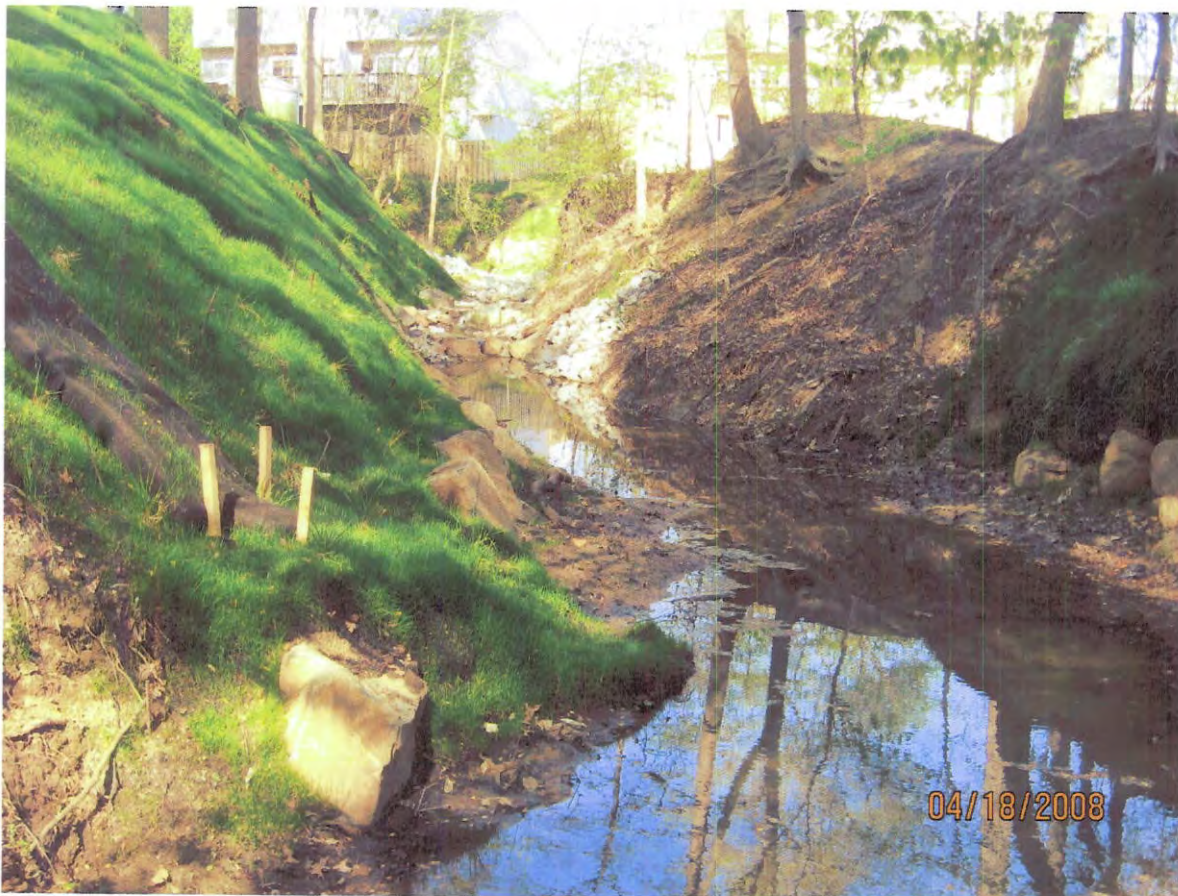
AFTER - Bank cut and stabilization (across from created sill).

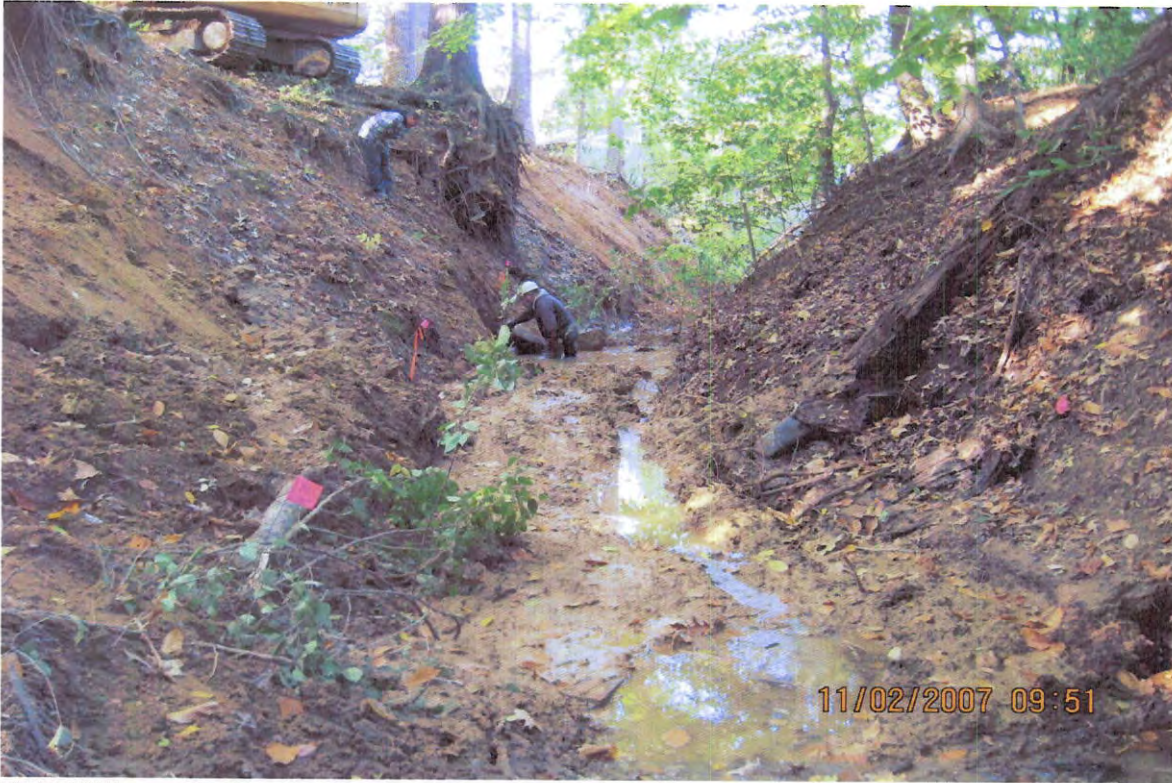
BEFORE –need stone toe treatment , grade bank and stream bank to be covered with compost tea.

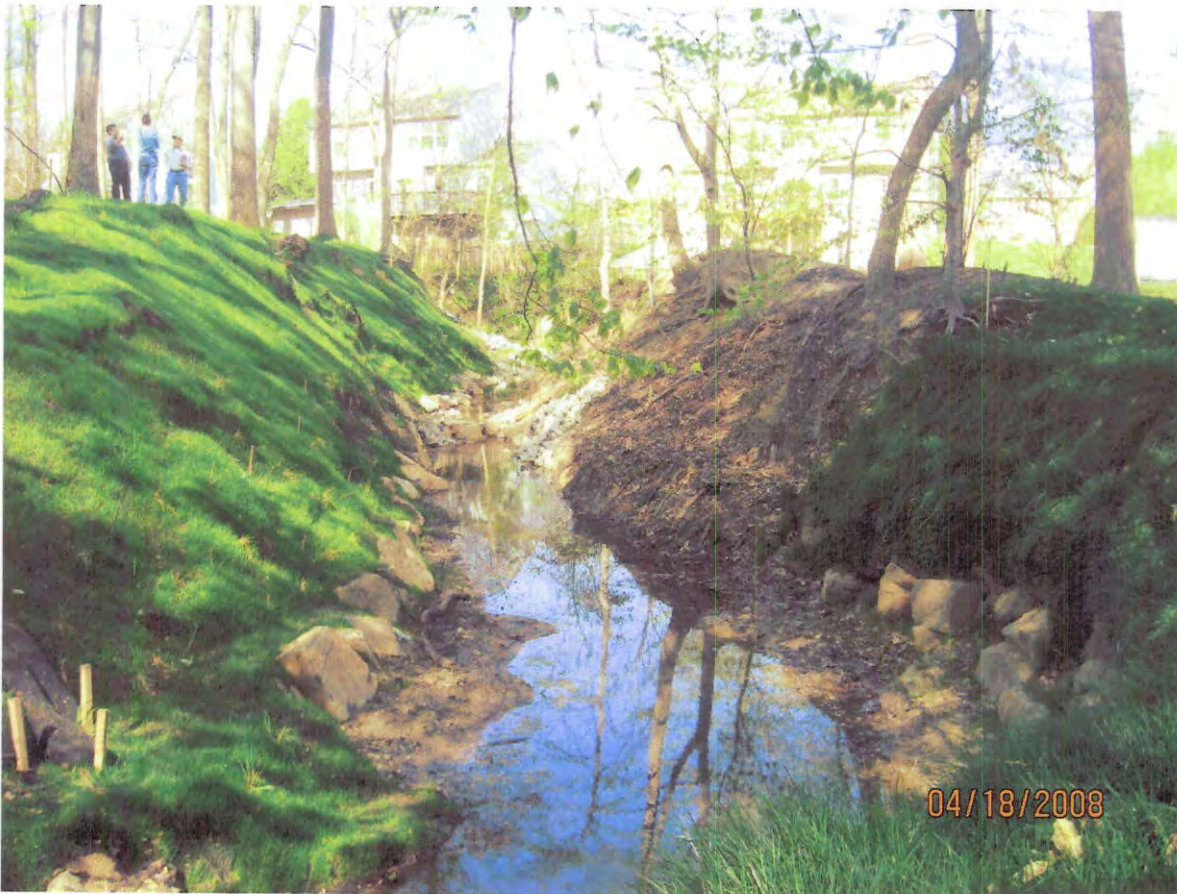
AFTER - stone toe stabilization and bank covered with compost tea.

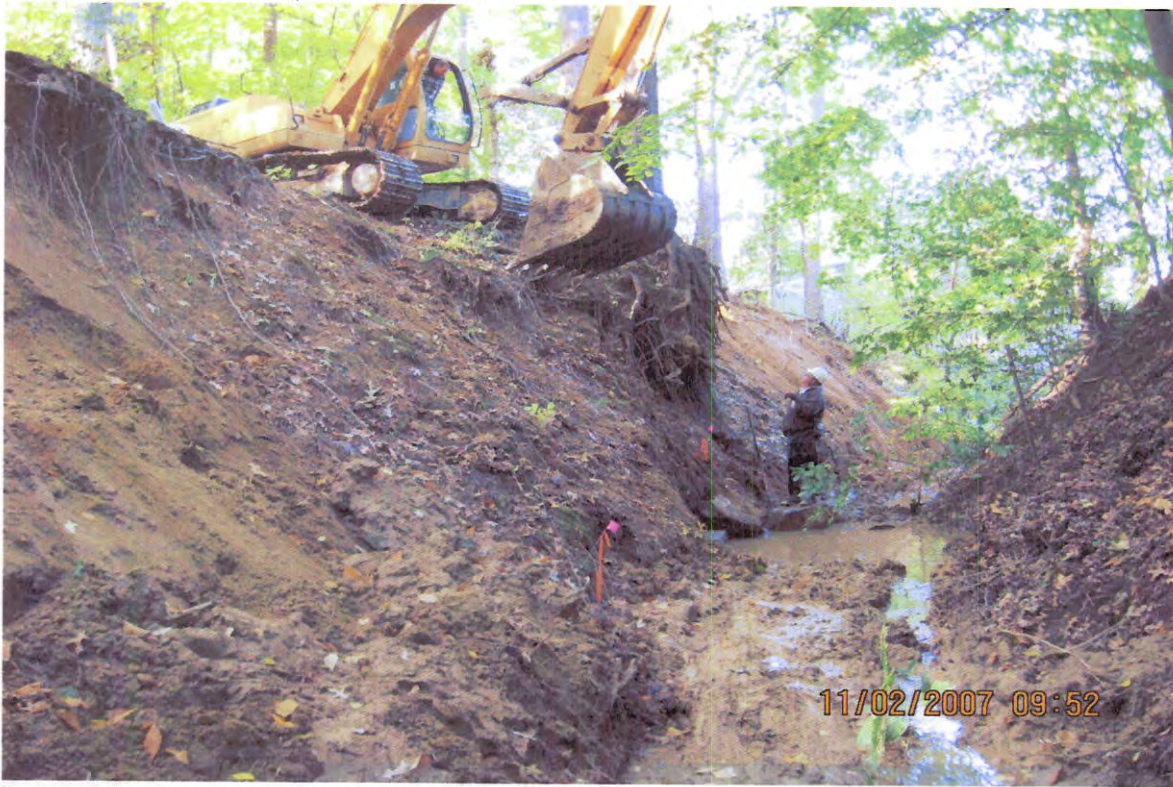
BEFORE - Location for rock weir #5.

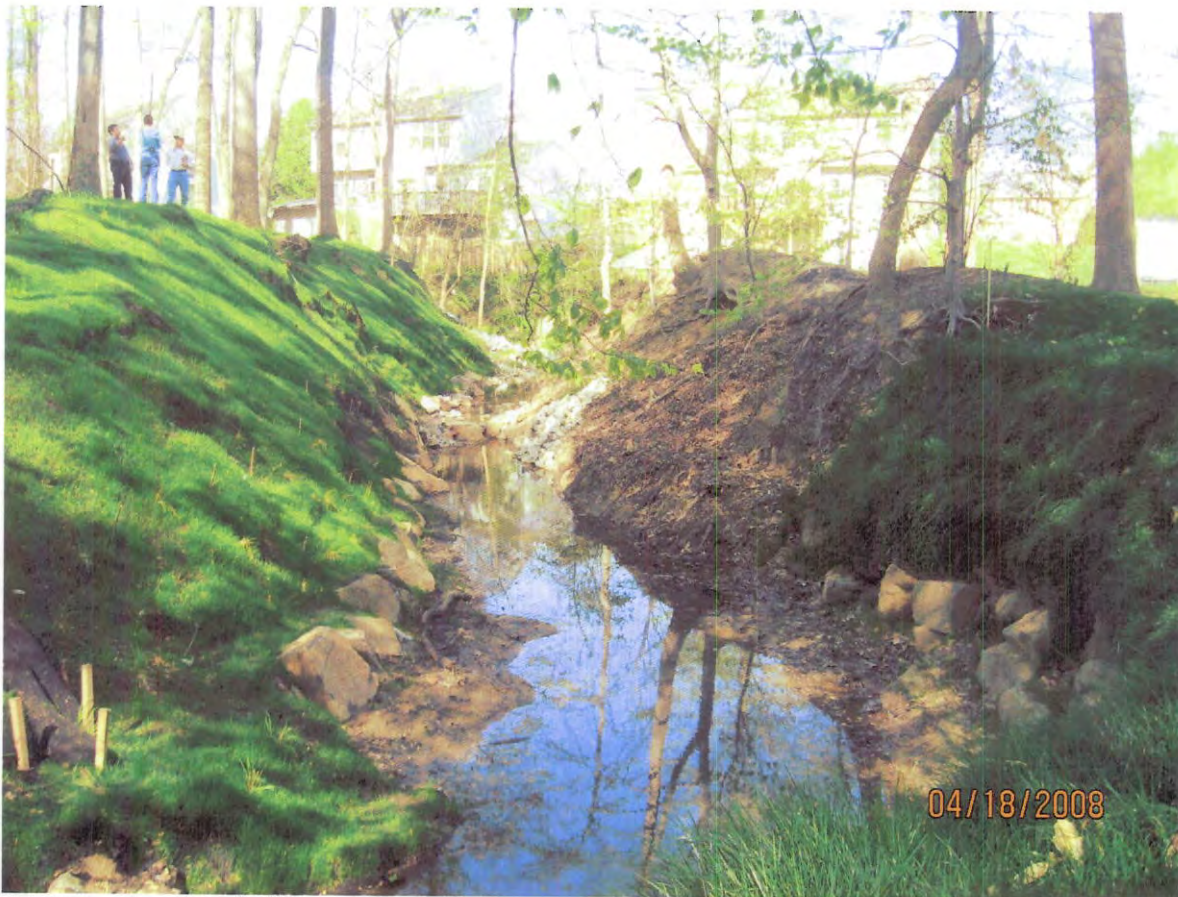
AFTER - Rock weir #5.

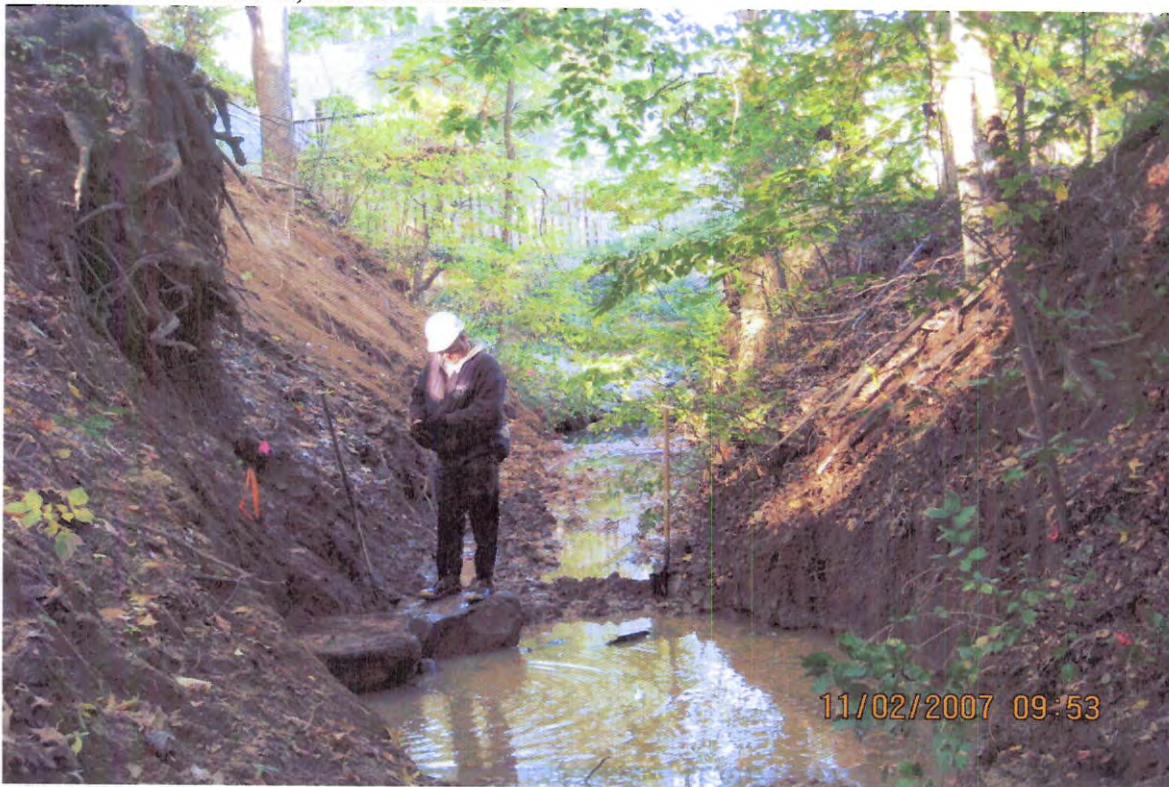
BEFORE - Rock weir #5 under construction.

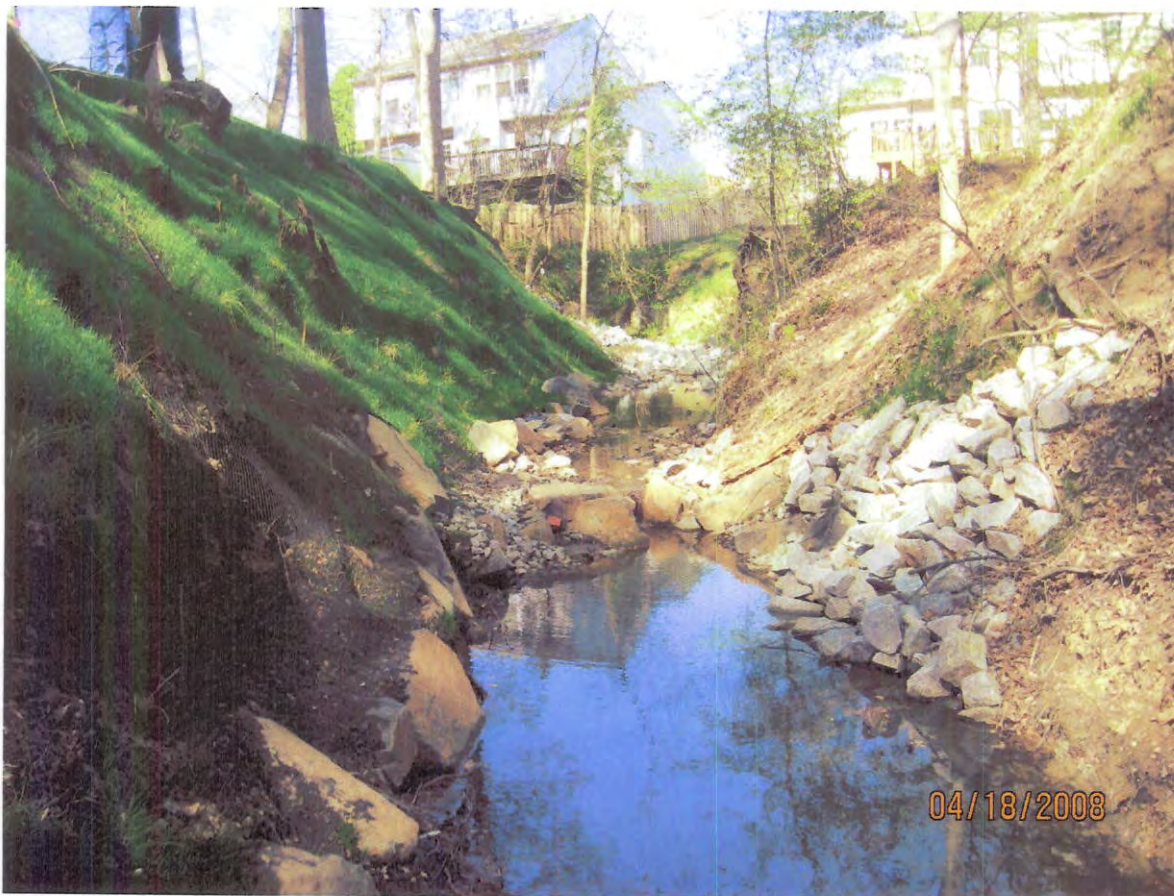
AFTER - rock weir #5.

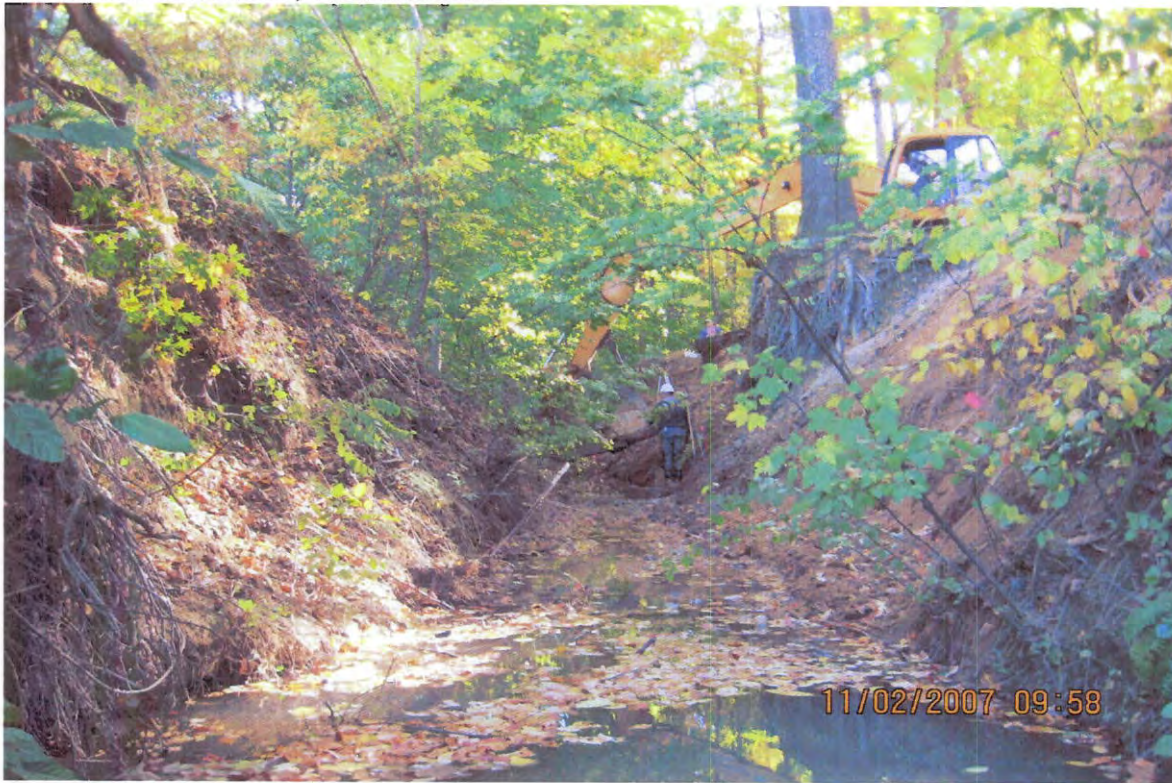
BEFORE – Above weir #5.

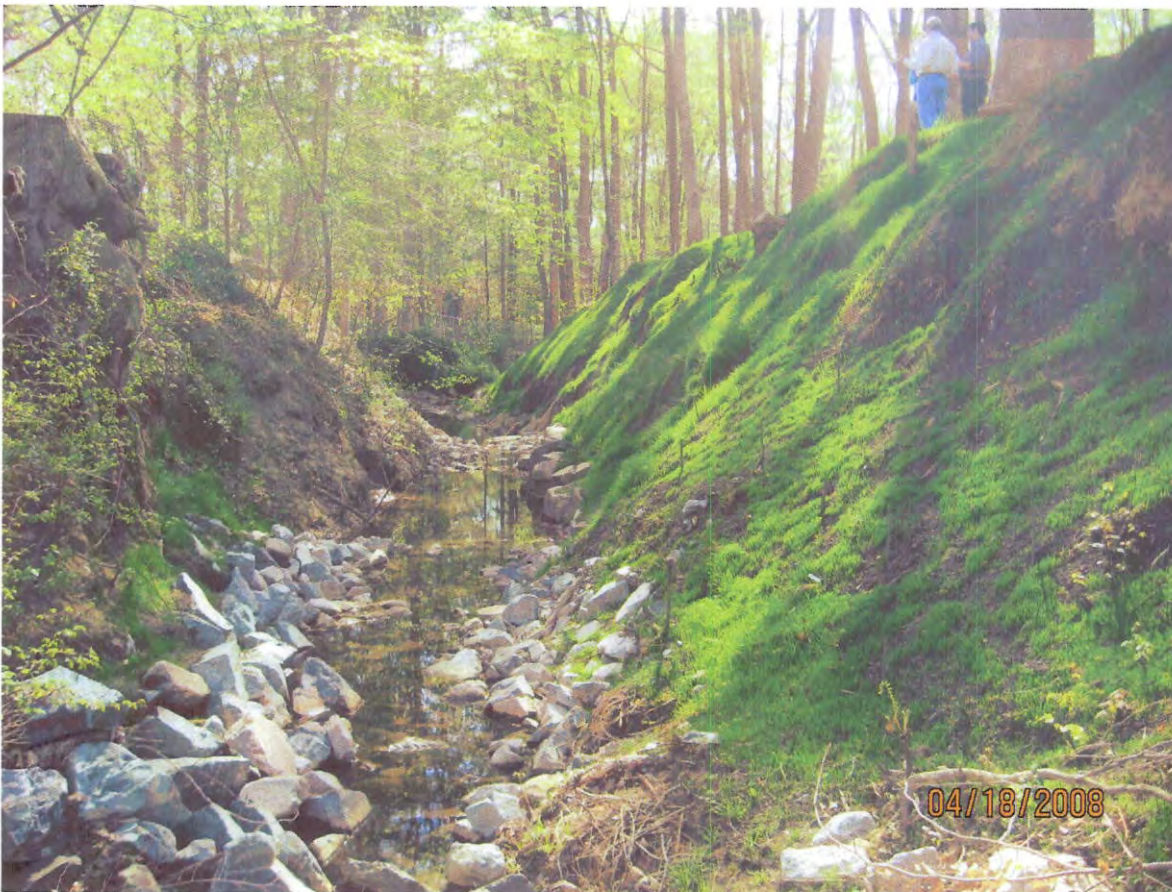
AFTER – Above weir #5, rock toe protection, lock down netting on slope and compost tea over netting.

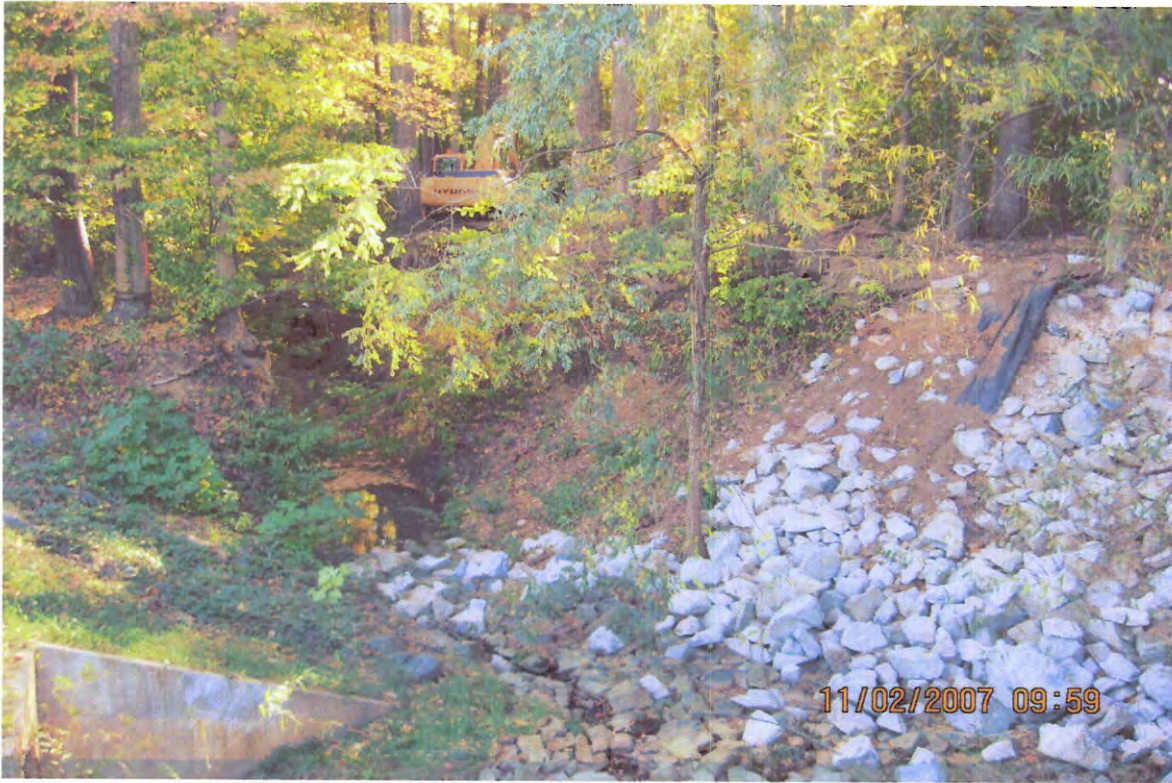
BEFORE - At outfall of pond #343, additional placement of rip rap along the slope.

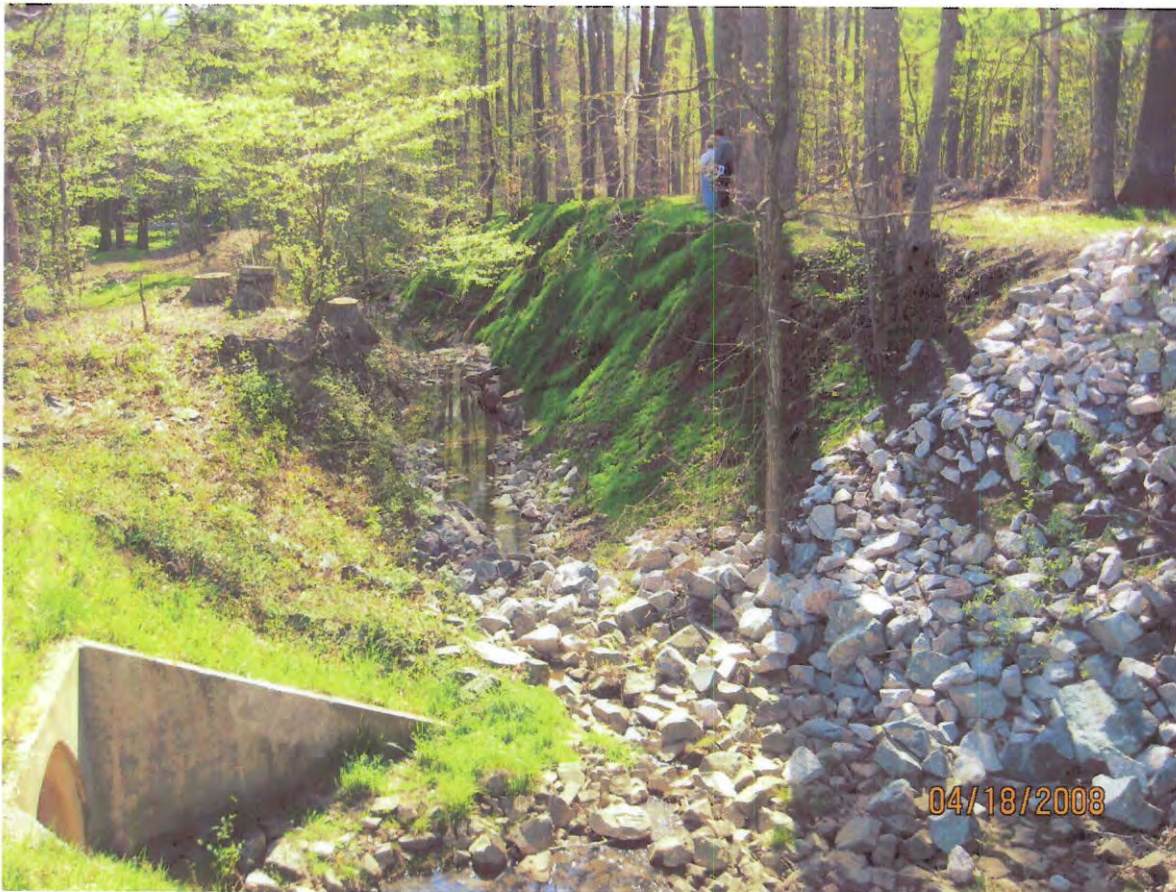
AFTER - At outfall of pond #343, additional placement of rip rap along the slope.
