PW Parkway ES

WSSI #21315.03

Waters of the U.S. (Including Wetlands) Delineation and Resource Protection Area Evaluation

October 23, 2015

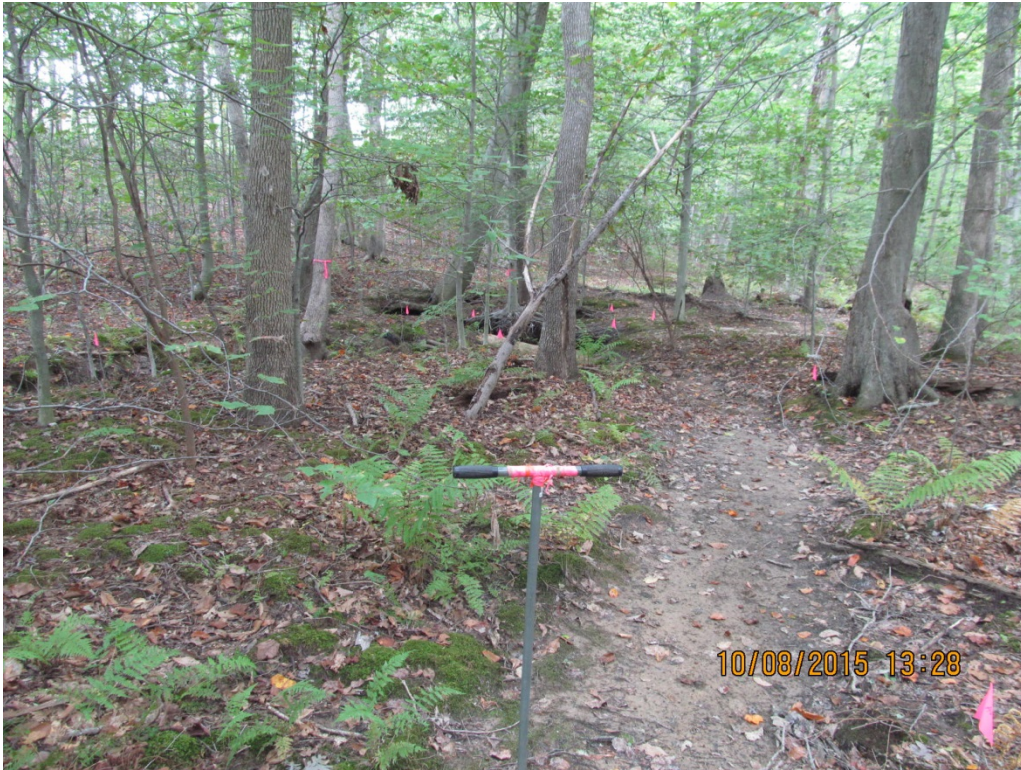
1. **Looking northeast at the palustrine forested wetland adjacent to Stream Reach 3-B present in the northeastern portion of the study area.**

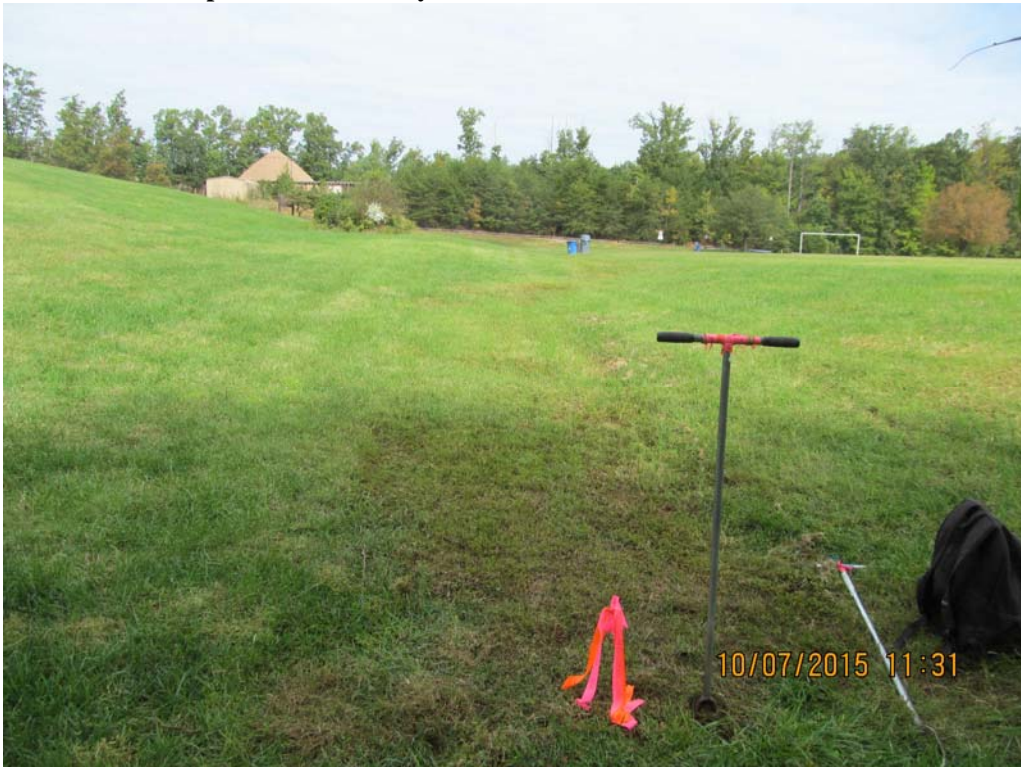
2. **Looking north at Data Point 1 which characterizes the upland swale present in the northeastern portion of the study area.**

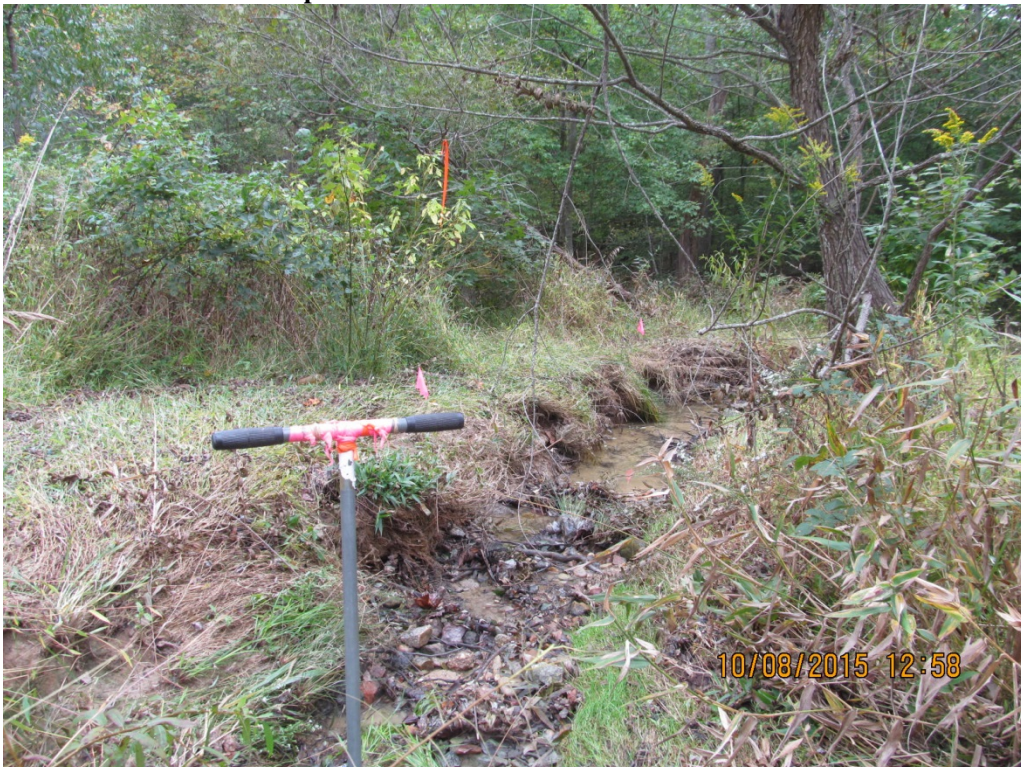
4. **Looking southeast (downstream) at Stream Reach 3-B, which flows in an eastern direction in the northeastern portion of the study area.**

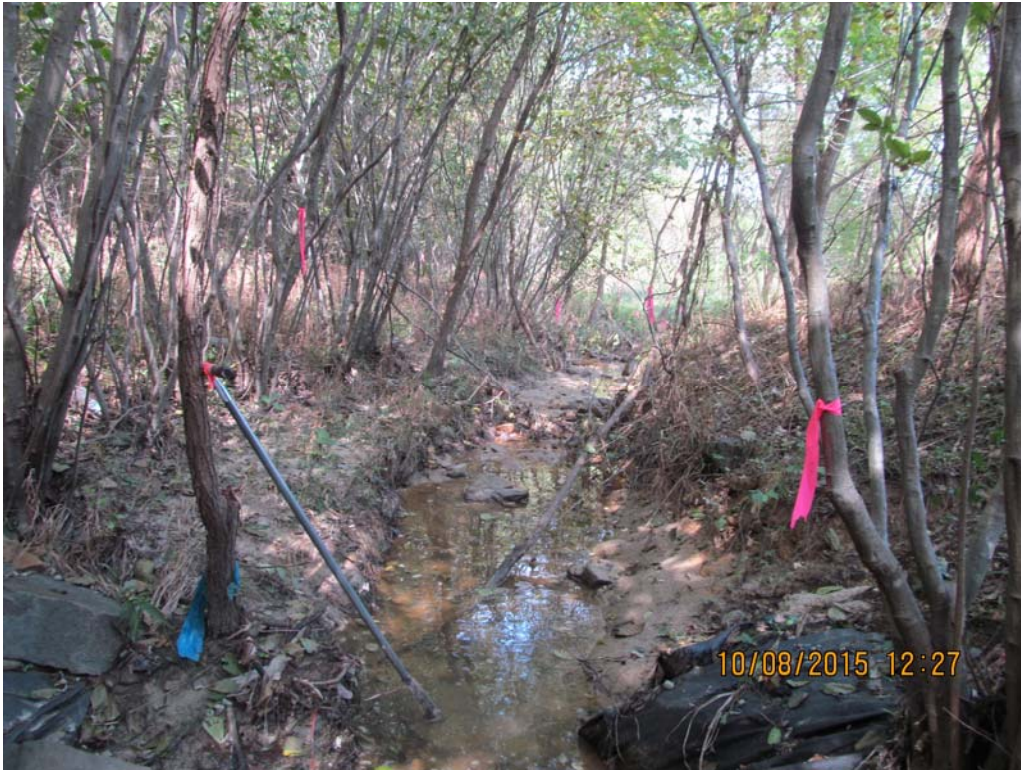
5. Looking northwest (upstream) at Stream Reach 3-A, an intermittent stream present in the northwestern portion of the study area. This stream scored 25 and 20 on the NCDWQ and DPWES methods, respectively. Stream assessment scores below the intermittent/perennial threshold, combined with weak biology and discontinuous flow, indicate that flow within this stream is intermittent.

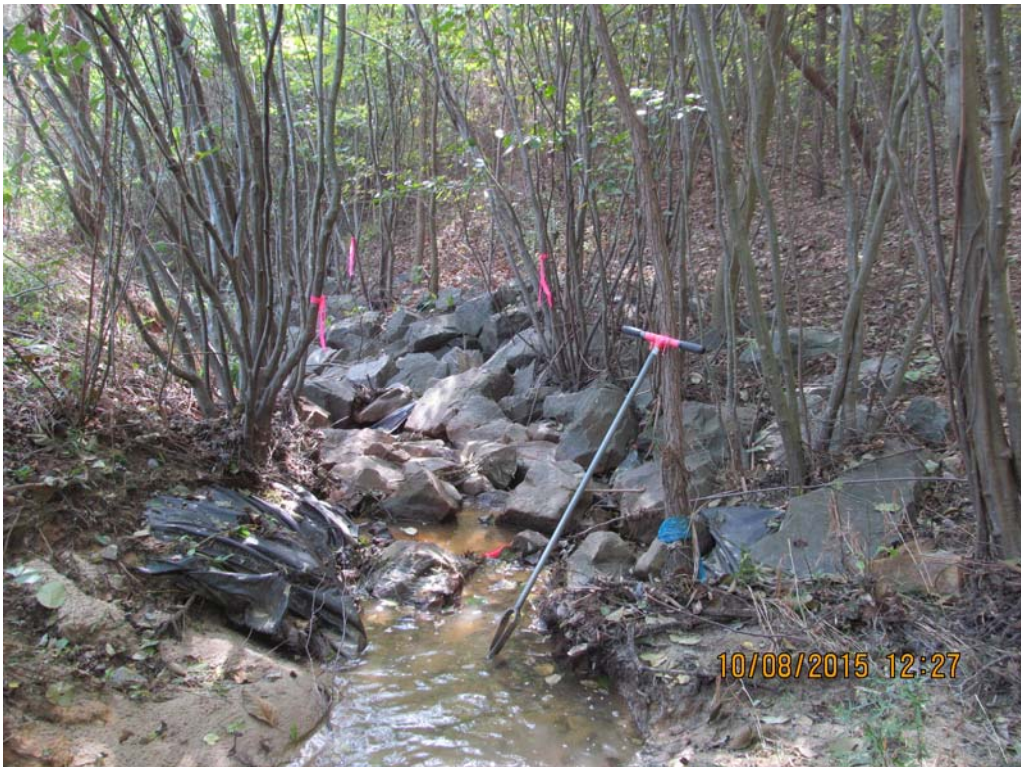
6. Looking southeast (downstream) at Stream Reach 3-A, which flows eastward in the northeastern portion of the study area.

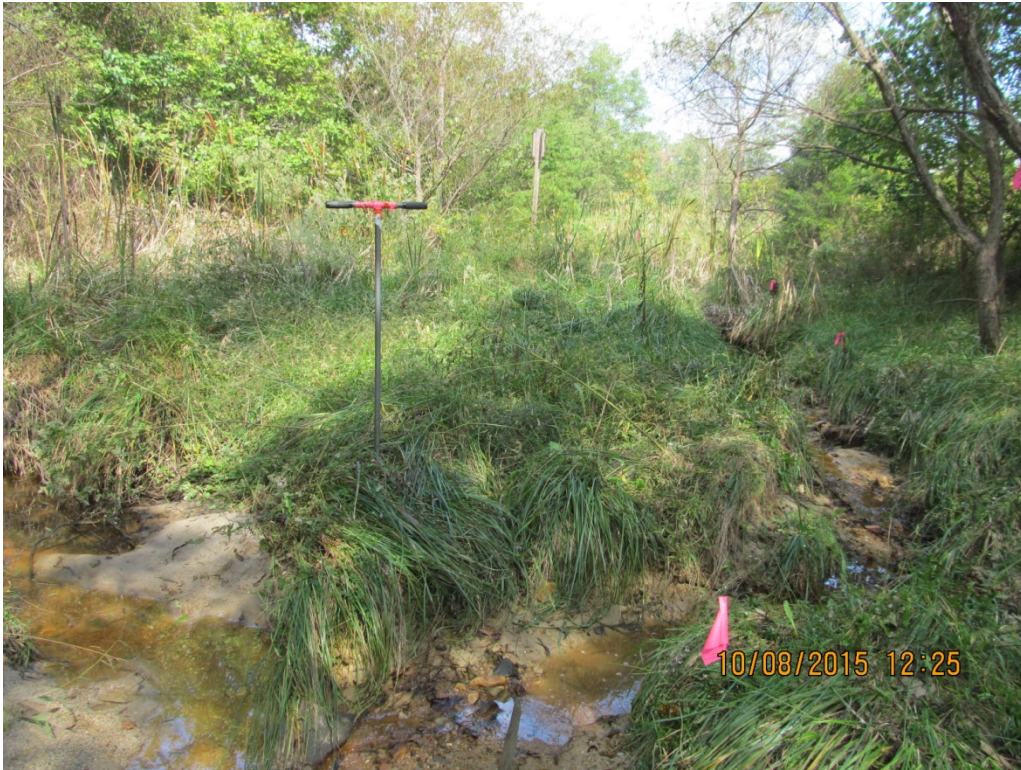
7. Looking northwest at the palustrine emergent wetland adjacent to Stream Reach 2-A present in the northern portion of the study area.

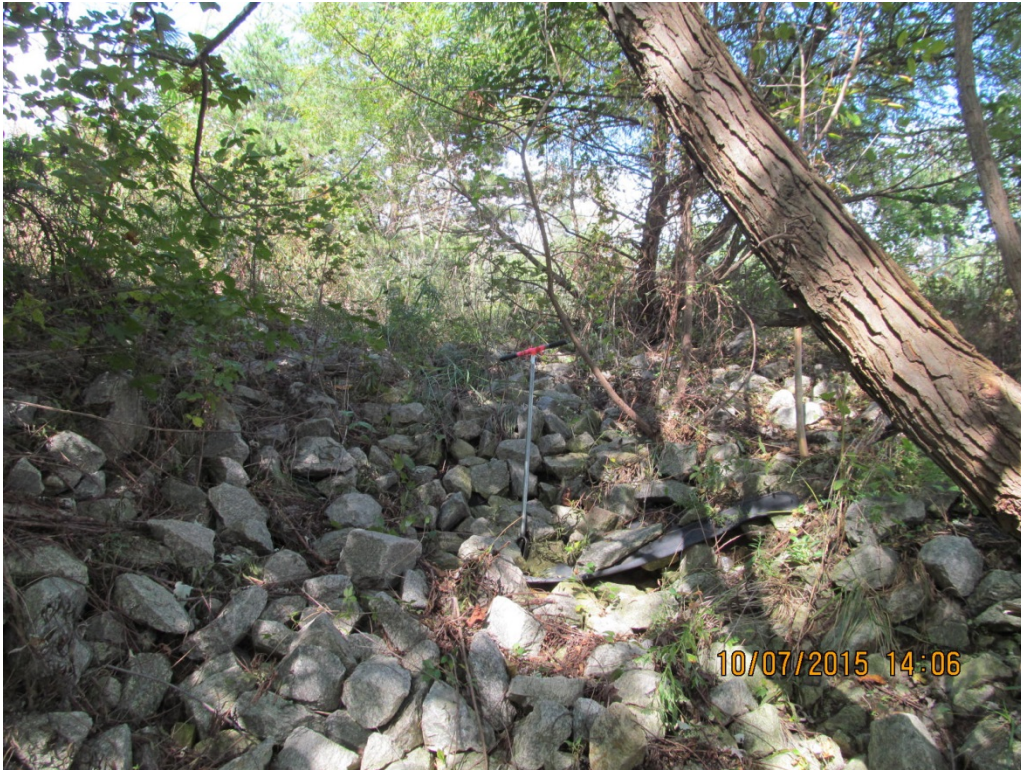
11. Looking north at the upland swale present in the northern portion of the study area.

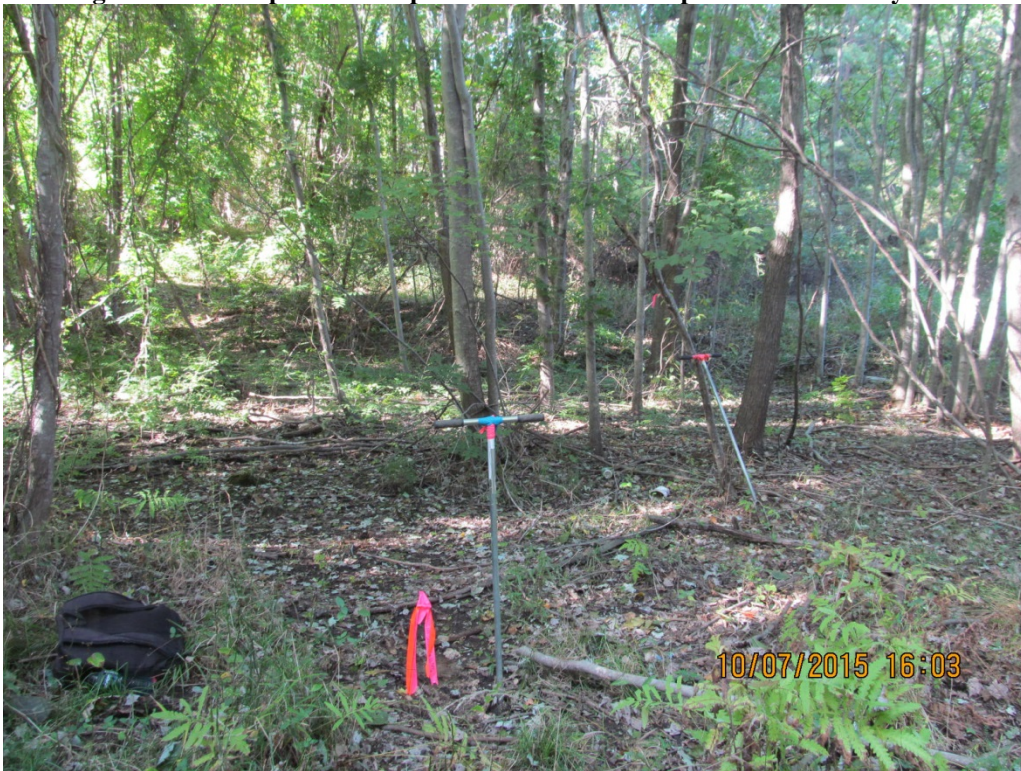
12. Looking northwest at Data Point 2 which characterizes the palustrine forested wetland present in the northern portion of the study area.

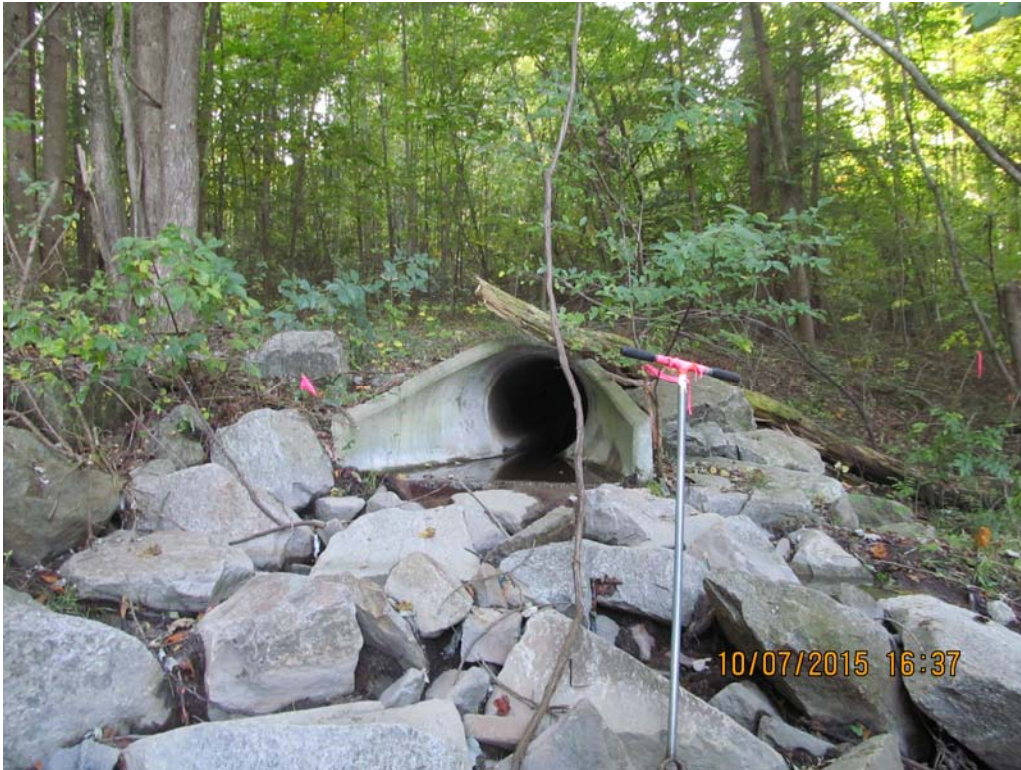
15. Looking southwest at the culvert present along Stream Reach 2-A present in the northwestern portion of the study area.

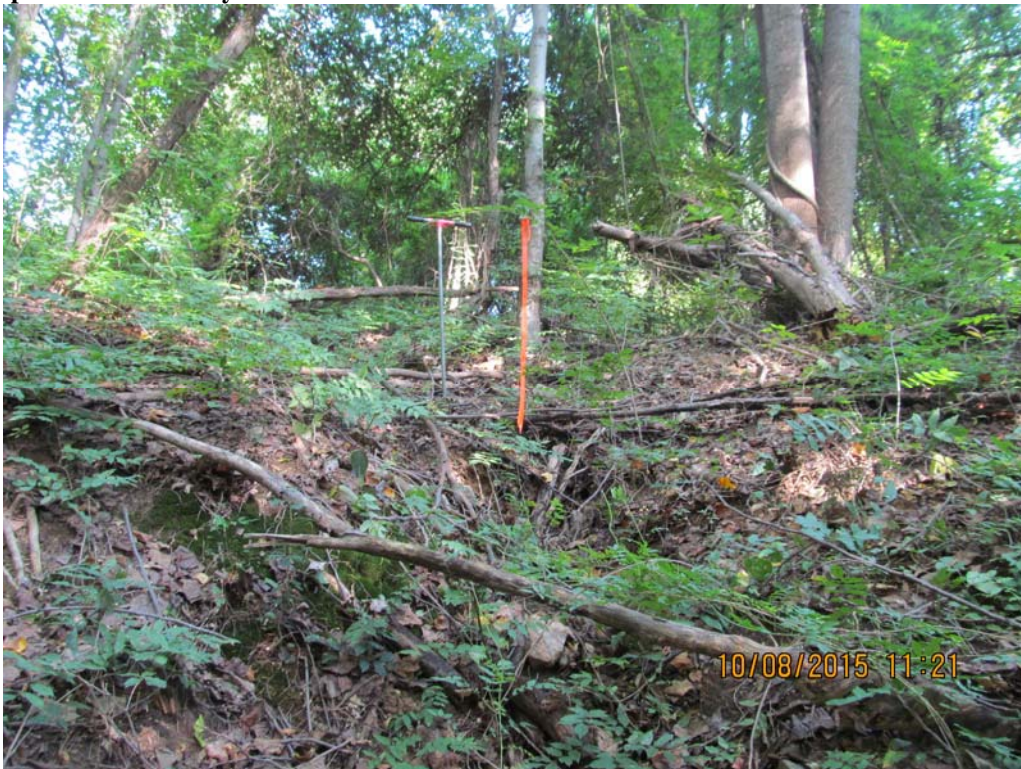
16. Looking north at the upland swale present in the northwestern portion of the study area.

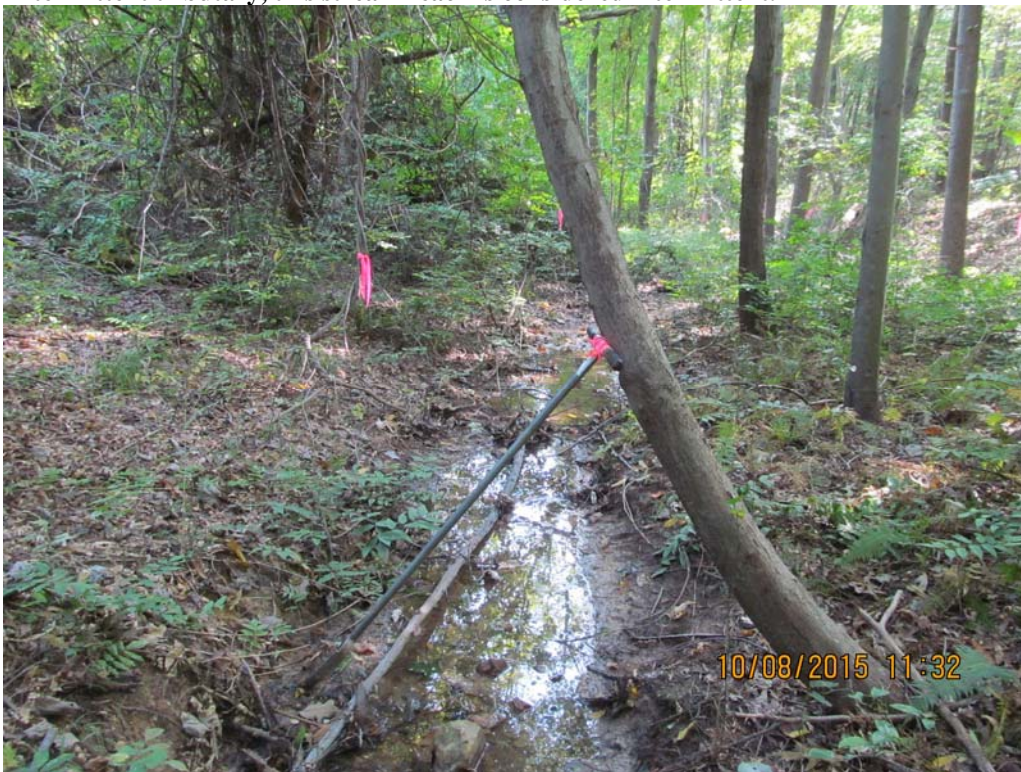
18. Looking east (downstream) at the intermittent tributary present in the northwestern portion of the study area.

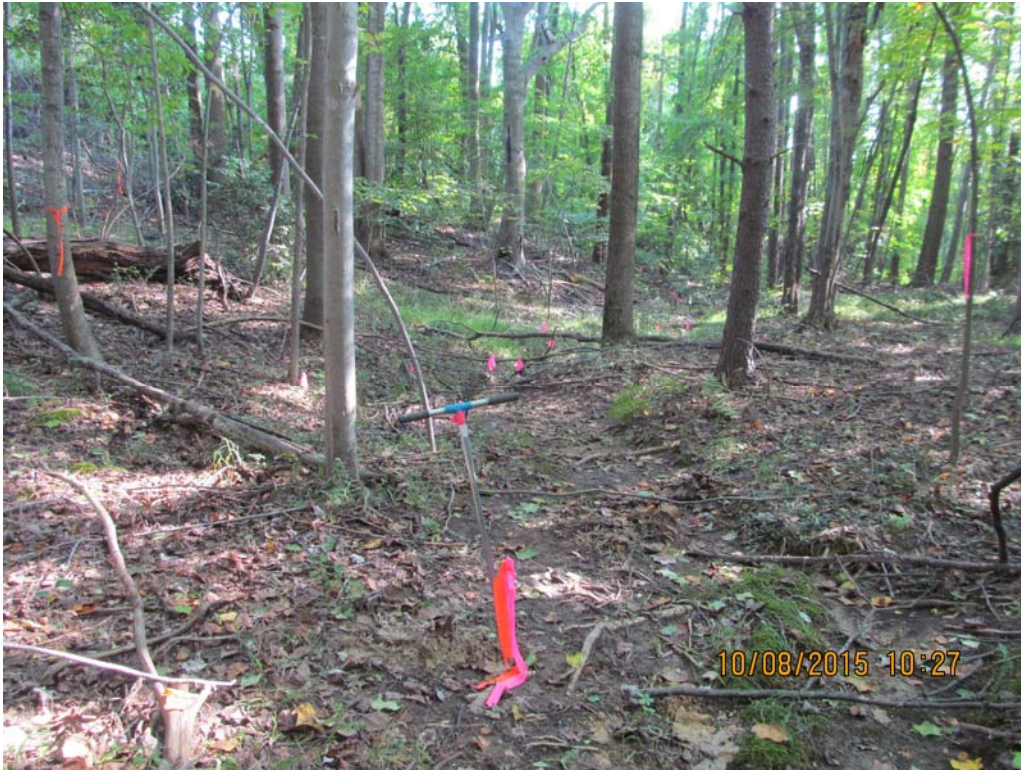
19. Looking northeast at Data Point 3 which characterizes the palustrine forested wetland present in the northwestern portion of the study area.

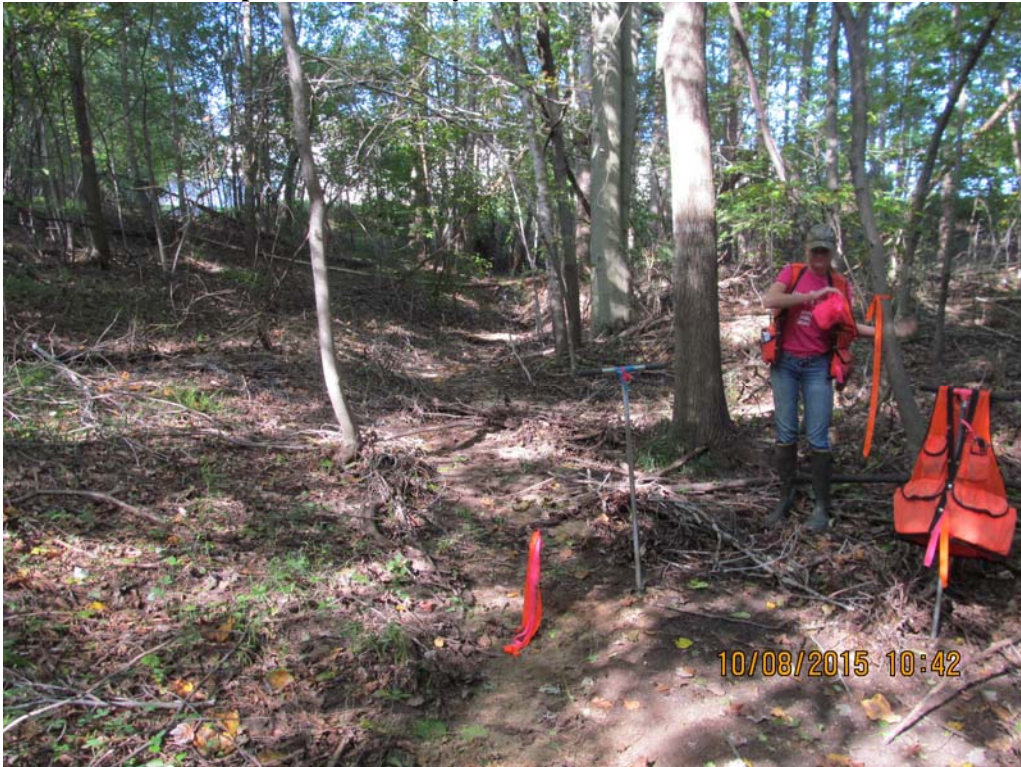
20. Looking west at Data Point 4 which characterizes the upland swale present upslope of the palustrine forested wetland in the northwestern portion of the study area.

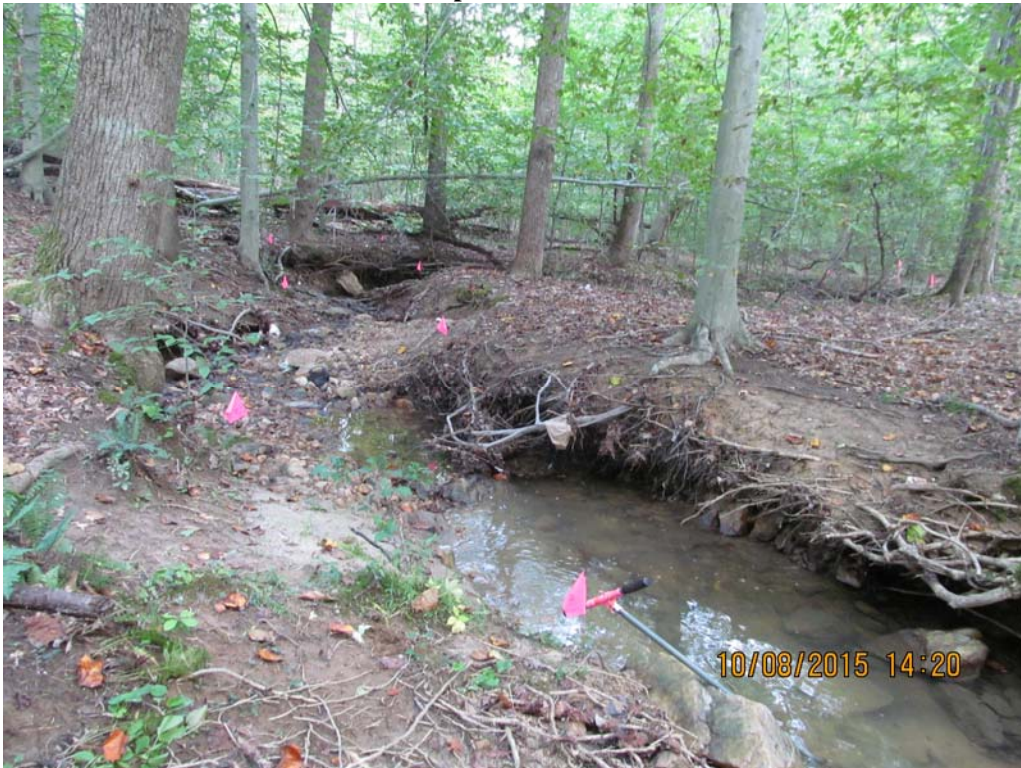
24. Looking northeast (downstream) at Stream Reach 4-A, which flows in a northeastern direction through the southeastern portion of the study area.

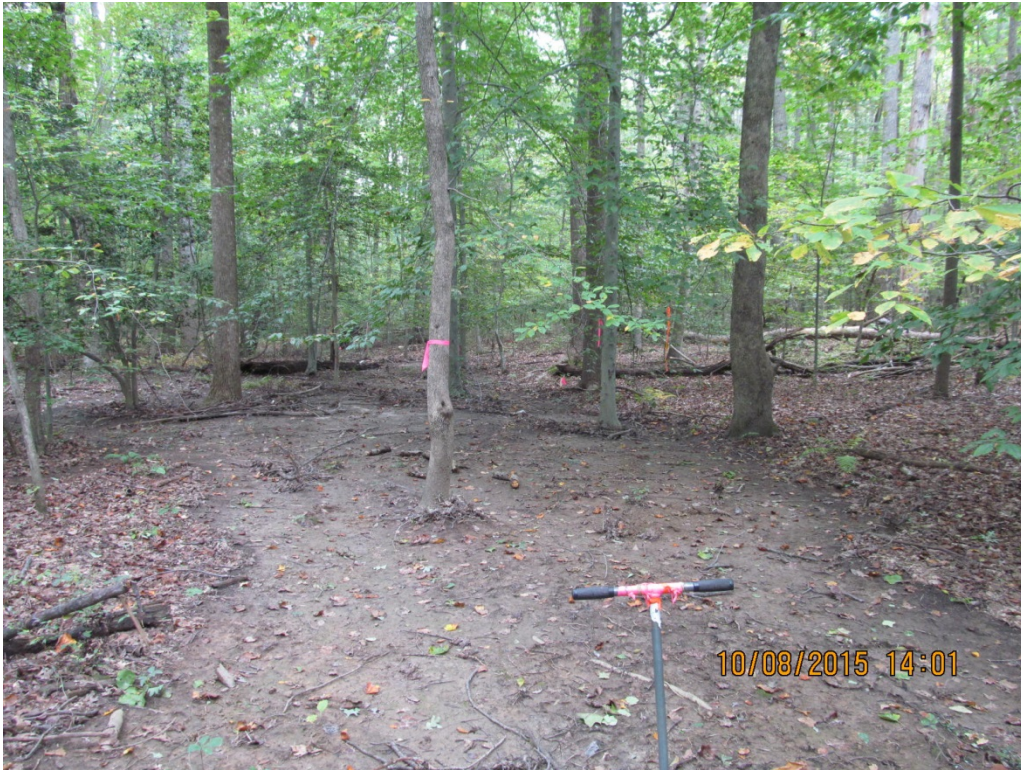
25. Looking northeast at the palustrine forested wetland present in the southeastern portion of the study area.

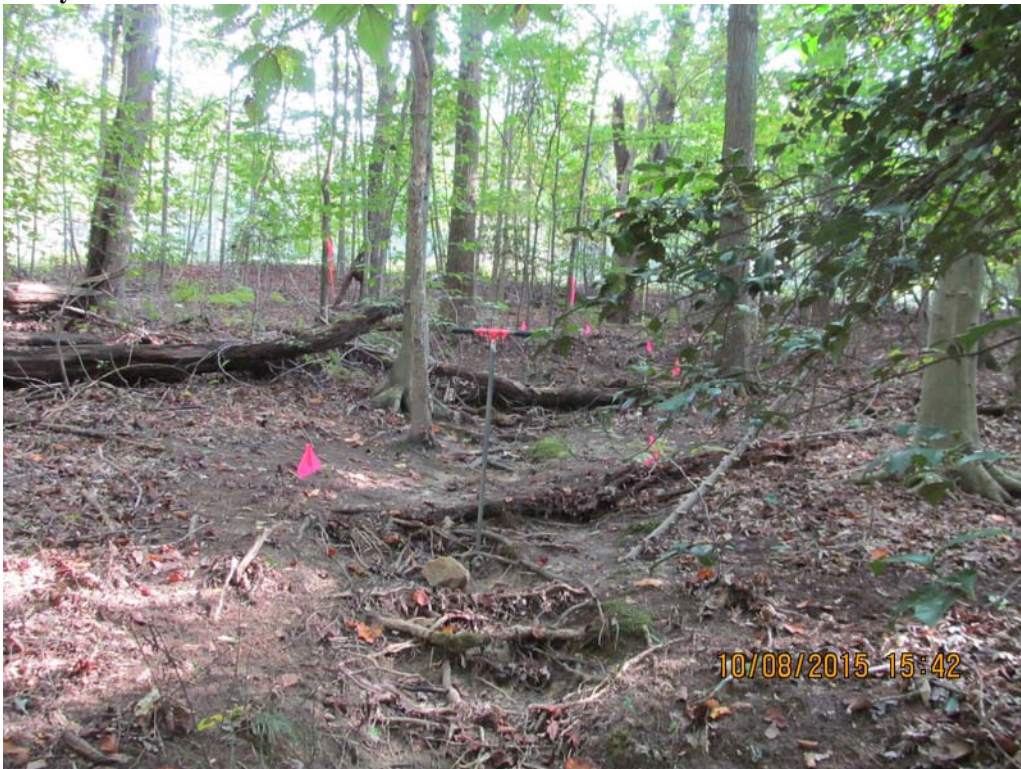
26. Looking southeast at the non-jurisdictional upland swale present in the southeastern portion of the study area.

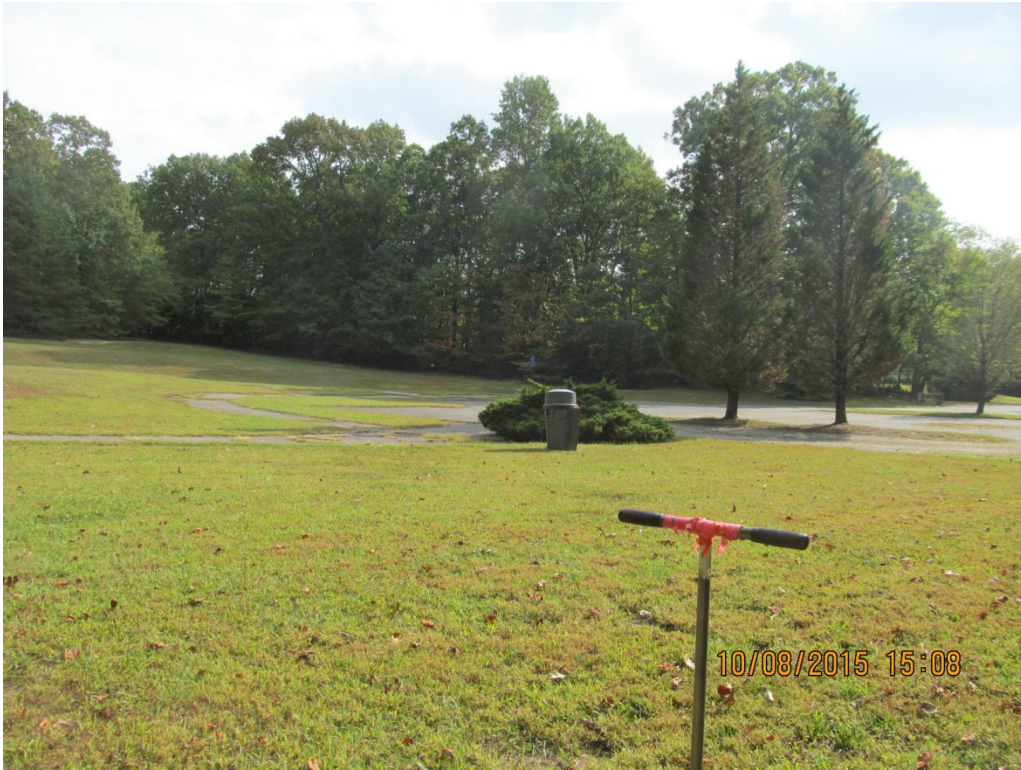
27. Looking southwest at the parking lot and maintained lawns present in the southeastern portion of the study area. No WOUS are present in this area.

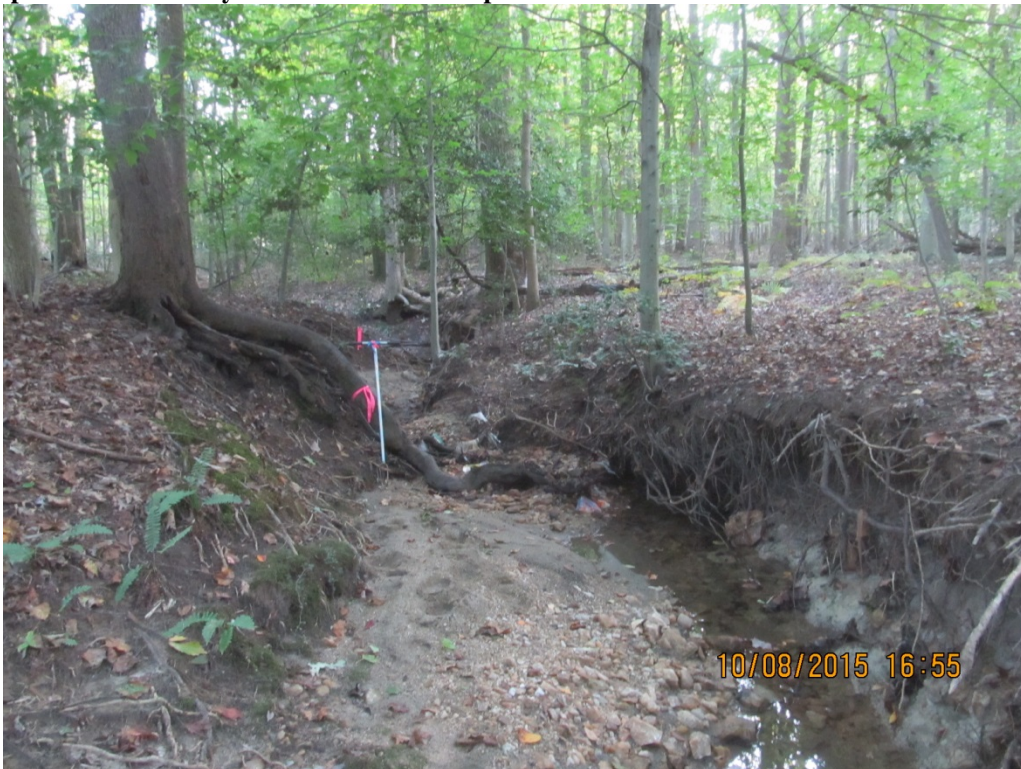
28. Looking south (upstream) at Stream Reach 4-B, an intermittent stream present in the southeastern portion of the study area. This stream scored 23.5 and 18.5 on the NCDWQ and DPWES methods, respectively. Stream assessment scores below the intermittent/perennial threshold, combined with the absence of biological indicators of perennial flow and moderate presence of baseflow, indicate that flow within this stream is intermittent.

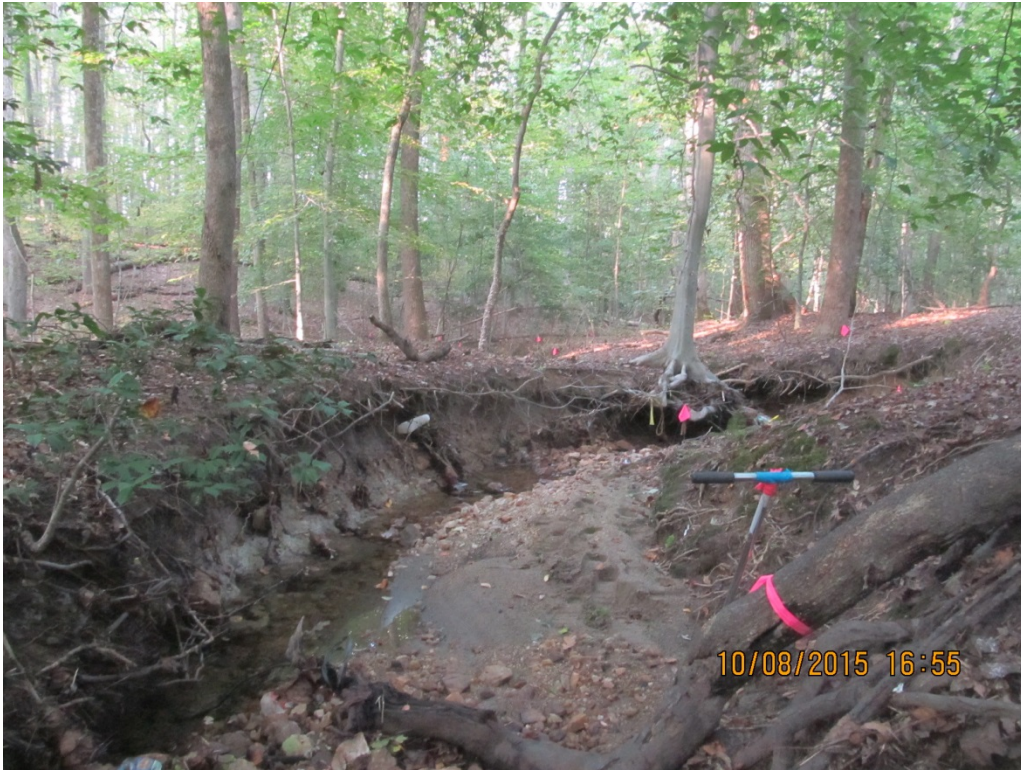
29. Looking northeast (downstream) at Stream Reach 4-B, which flows in a northern direction through the southeastern portion of the study area.

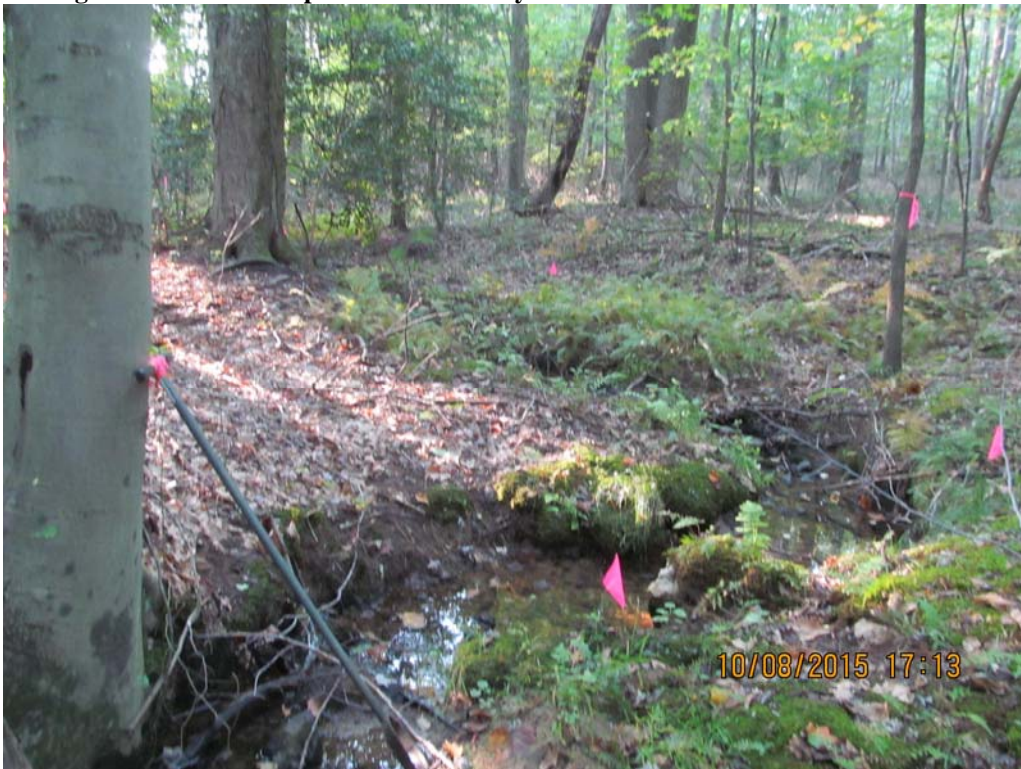
30. Looking northwest (upstream) at Stream Reach 4-C, an intermittent stream present in the southeastern portion of the study area. This stream scored 27 and 22 on the NCDWQ and DPWES methods, respectively. Stream assessment scores below the intermittent/perennial threshold, combined with the absence of biological indicators of perennial flow, moderate presence of baseflow, and a first order channel, indicate that this stream is intermittent.

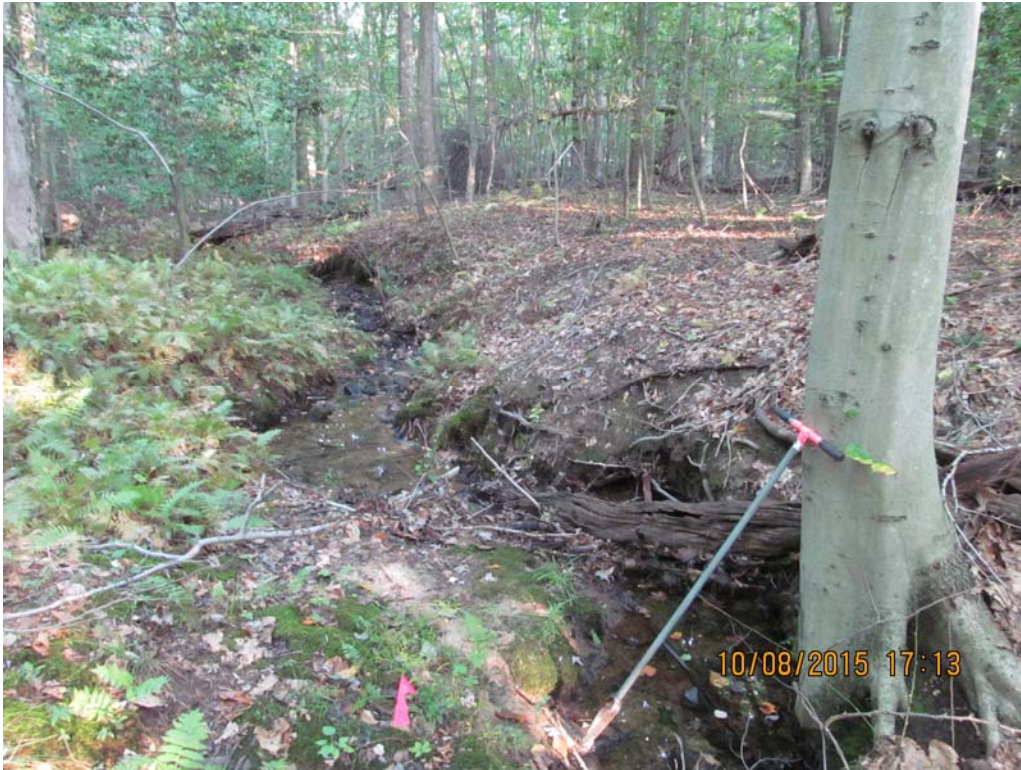
- 31. Looking southeast (downstream) at Stream Reach 4-C, which flows in an eastern direction through the southeastern portion of the study area.**
