# Proposed Changes to Design and Construction Standards Manual Section 700

September 2019

Marc Aveni Environmental Services

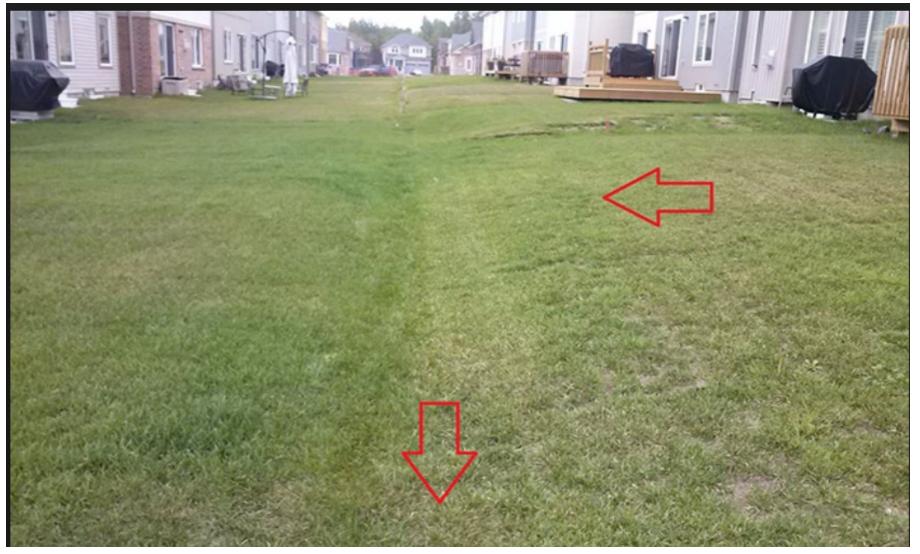
Example of a swale

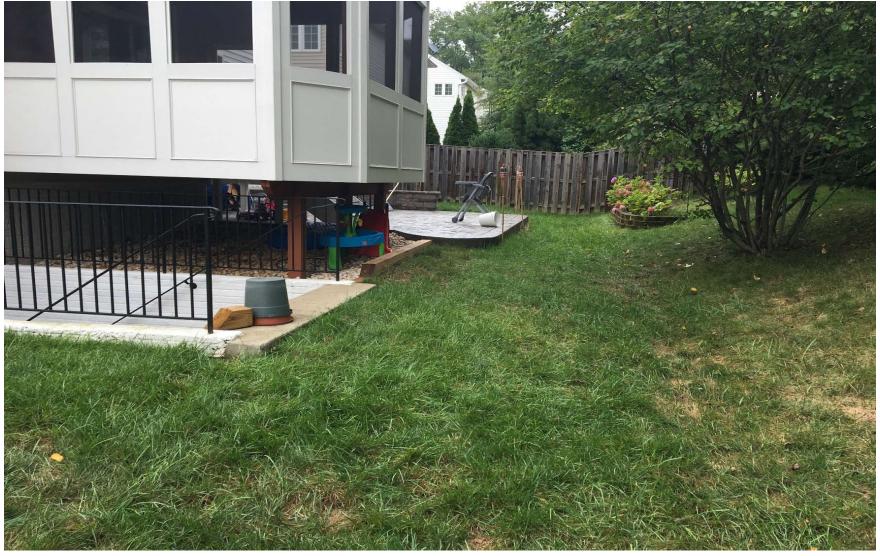
Lack of defined swale directly behind house – note proximity to walk up basement entry

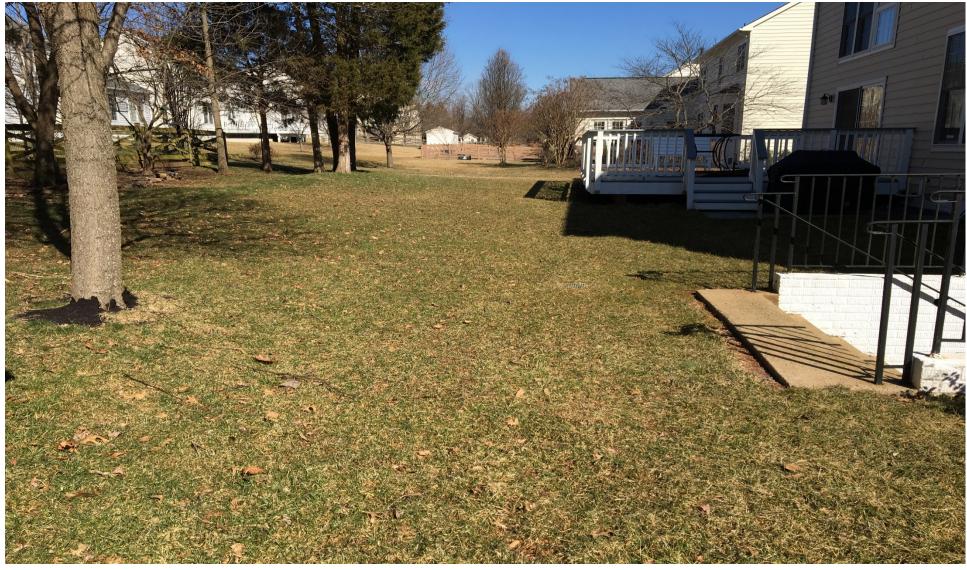
|10|

Lack of defined swale

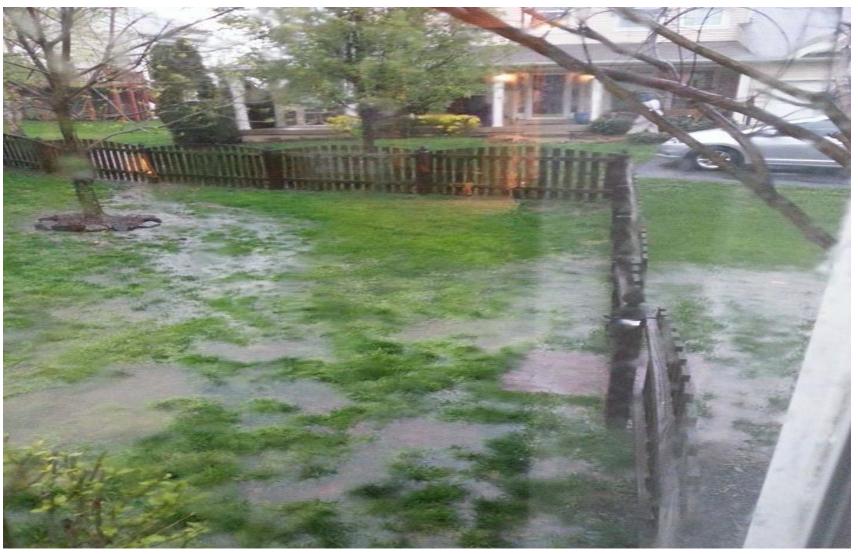
Lack of defined swale causing yard flooding

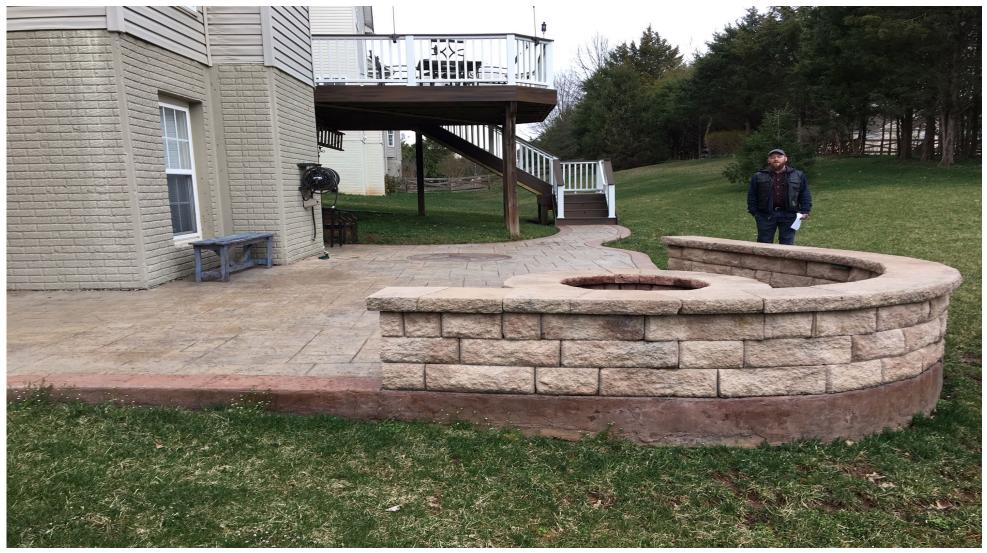
Patio about 15 feet from house

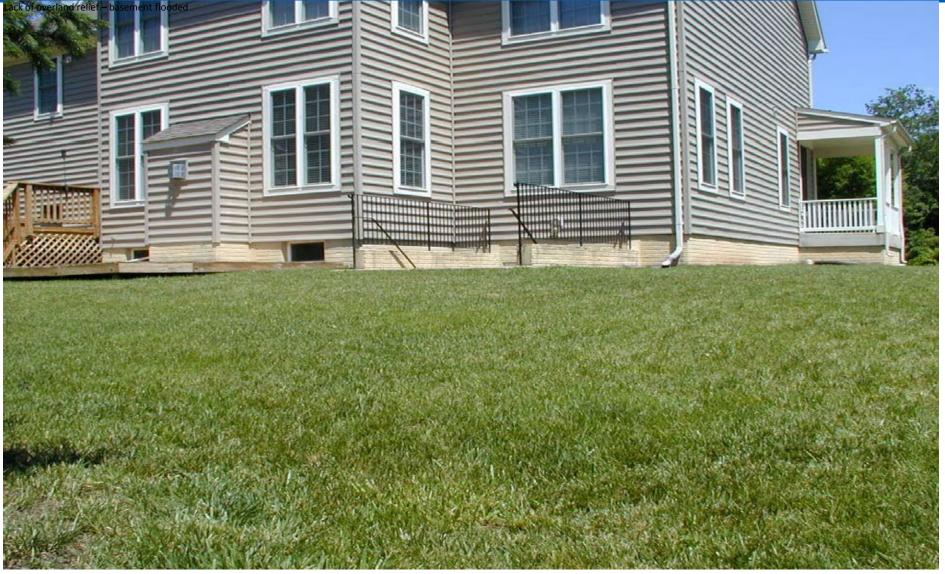
Lack of overland relief led to basement flood

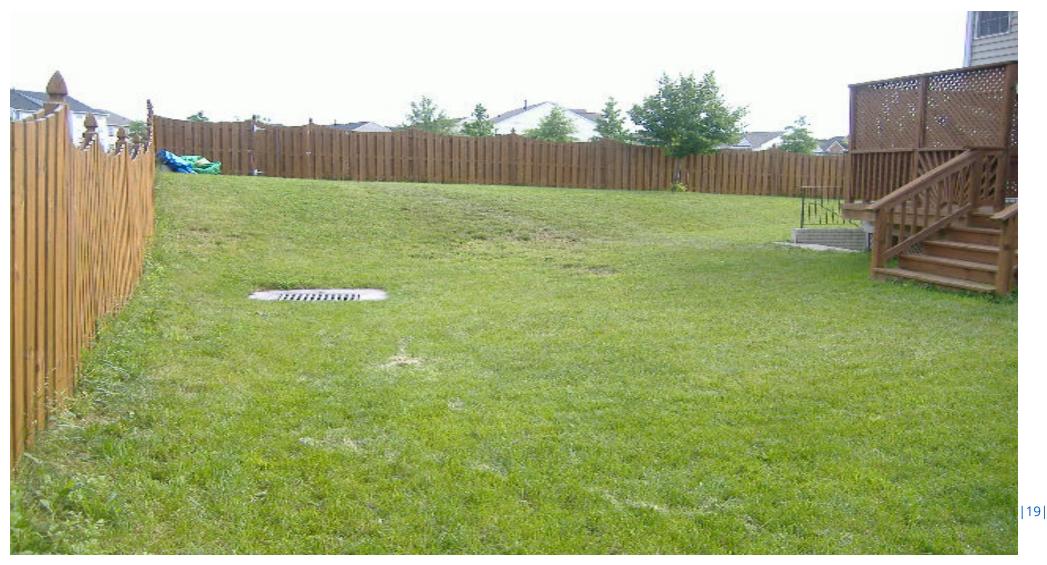
Drop inlet handling large flows close to basement entrance

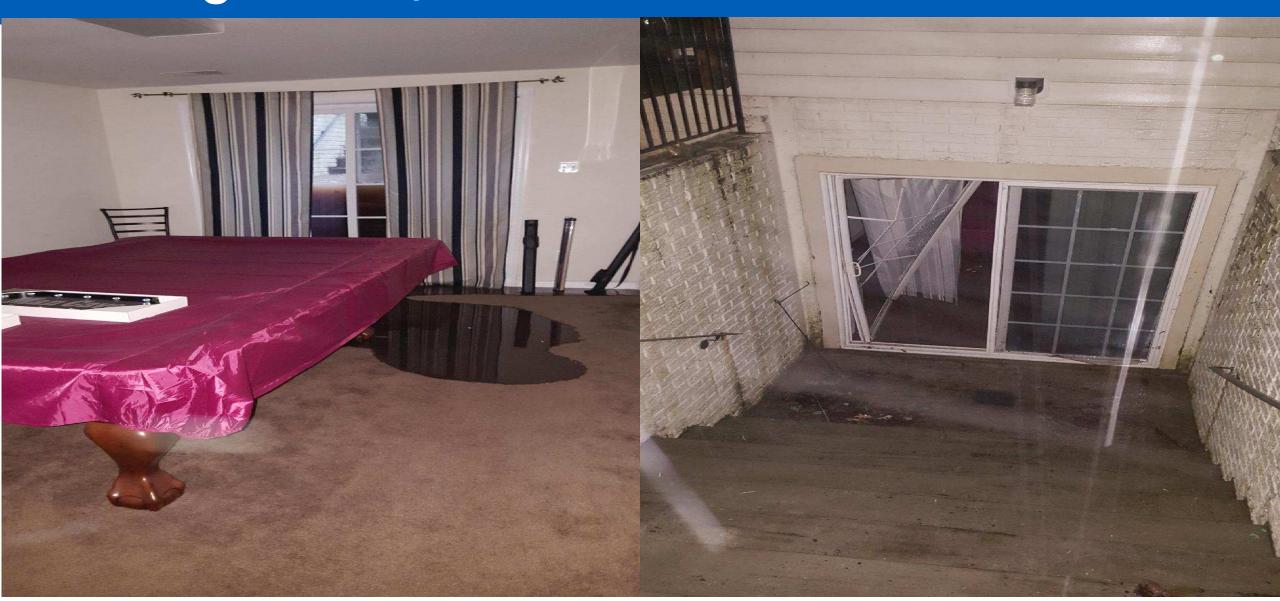
Flooded basement
